Access Compliance Report

Public Rights-of-Way

(Curb Ramps)

Intersection ID: 8343	Main Street: ATANDO_AV	Cross Street: POINSETT_ST	Location: W
ADA ID: 2D8BFFE766F3	Ramp Type: PerpDiag	Initial Pass/Fail: Fail	Overall Compliance: No
Severity Score: 22.5			
Codes/Mitigation Info/Possible Solution		Field Measurements/Component Compliance

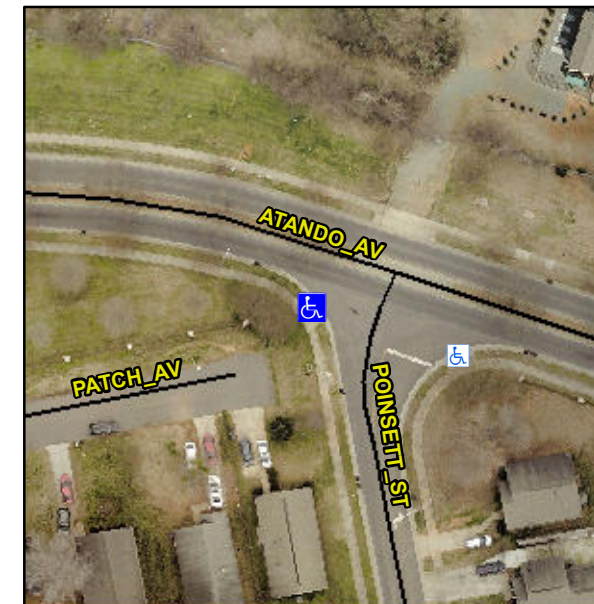
R304.5.1, R304.2.2, R304.5.3

Compliance	Description	Data	Compliance	Description	Data
N/A	Ramp Length (in)	59.0	No	Ramp Slope (%)	9.5
No	Ramp Width (in)	45.0	No	Ramp XSlope (%)	2.1
N/A	Flare Type LT	N/A	N/A	Flare Type RT	N/A
N/A	Flare Slope LT (%)	N/A	N/A	Flare Slope RT (%)	N/A
N/A	Flare Traversable LT?	N/A	N/A	Flare Traversable RT?	N/A
N/A	Landing Length (in)	N/A	N/A	DWS Provided?	N/A
N/A	Landing Width (in)	N/A	N/A	DWS Contrast?	N/A
N/A	Landing Slope (%)	N/A	N/A	DWS Length (in)	N/A
N/A	Landing X Slope (%)	N/A	N/A	DWS Full Width?	N/A
N/A	Landing Curb? (Y/N)	N/A	N/A	DWS Offset (in)	N/A
N/A	Shared Landing?	N/A			
N/A	Gutter Ponding?	N/A	N/A	Gutter Slope (%)	N/A
N/A	Gutter Lip Ht (in)	N/A	N/A	Gutter X Slope (%)	N/A
N/A	Painted X Walk1?	No	N/A	Painted X Walk2?	No
	X Walk 1 Direction	To SE		X Walk 2 Direction	To NE
N/A	X Walk 1 Width (in)	N/A	N/A	X Walk 2 Width (in)	N/A
	X Walk 1 Slope (%)	3.0		X Walk 2 Slope (%)	1.1
	X Walk 1 X Slope (%)	0.3		X Walk 2 X Slope (%)	4.3

N/A	Ramp inside XWalk1?	N/A	N/A	Ramp inside XWalk2?	N/A
	Road Slope (%)	1.6	N/A	Clear Space?	N/A
	Road X Slope (%)	3.5	N/A	Clear Space to XWalk (in)	N/A
N/A	Any Obstructions?	N/A	N/A	Storm Grate/Utility Hazard?	N/A
	Obstruction Type			Storm Grate/Utility Type	
		N/A			N/A
			Yes	Surface Condition? (G/P)	Good

Remove & Replace Curb Ramp With Two New Directional Ramps or Equivalent.
