# Access Compliance Report

## Public Rights-of-Way

### (Curb Ramps)

Intersection ID: 10036062	Main Street: RIVERGATE_PY	Cross Street: N/A	Location: NE
ADA ID: 2DB5704DE3FF	Ramp Type: Perp	Initial Pass/Fail: Fail	Overall Compliance: No
Severity Score: 13.75			
Codes/Mitigation Info/Possible Solution		Field Measurements/Component Compliance

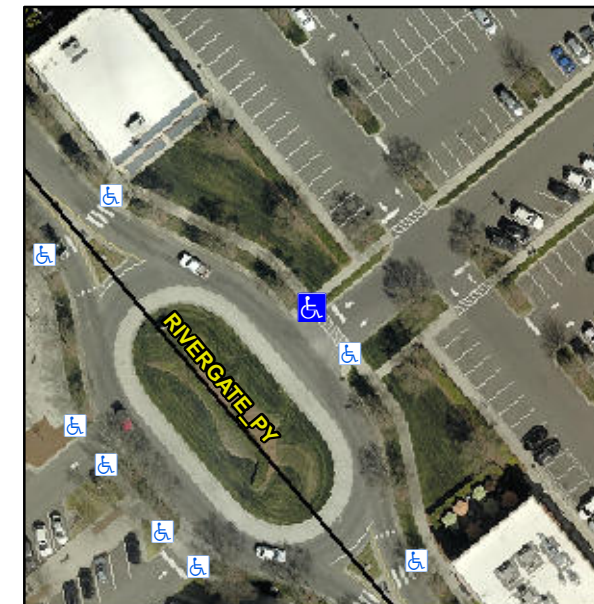
**Not Found, R304.2.2, R304.5.3**

Compliance	Description	Data	Compliance	Description	Data
N/A	Ramp Length (in)	49.0	No	Ramp Slope (%)	9.4
Yes	Ramp Width (in)	70.0	No	Ramp XSlope (%)	2.9
N/A	Flare Type LT	N/A	N/A	Flare Type RT	N/A
N/A	Flare Slope LT (%)	N/A	N/A	Flare Slope RT (%)	N/A
N/A	Flare Traversable LT?	N/A	N/A	Flare Traversable RT?	N/A
N/A	Landing Length (in)	N/A	N/A	DWS Provided?	N/A
N/A	Landing Width (in)	N/A	N/A	DWS Contrast?	N/A
N/A	Landing Slope (%)	N/A	N/A	DWS Length (in)	N/A
N/A	Landing X Slope (%)	N/A	N/A	DWS Full Width?	N/A
N/A	Landing Curb? (Y/N)	N/A	N/A	DWS Offset (in)	N/A
N/A	Shared Landing?	N/A			
N/A	Gutter Ponding?	N/A	N/A	Gutter Slope (%)	N/A
N/A	Gutter Lip Ht (in)	N/A	N/A	Gutter X Slope (%)	N/A
N/A	Painted X Walk1?	Yes	N/A	Painted X Walk2?	N/A
	X Walk 1 Direction	To SE		X Walk 2 Direction	N/A
N/A	X Walk 1 Width (in)	62.0	N/A	X Walk 2 Width (in)	N/A
	X Walk 1 Slope (%)	1.0		X Walk 2 Slope (%)	N/A
	X Walk 1 X Slope (%)	0.2		X Walk 2 X Slope (%)	N/A

N/A	Ramp inside XWalk1?	Yes	N/A	Ramp inside XWalk2?	N/A
	Road Slope (%)	N/A	N/A	Clear Space?	N/A
	Road X Slope (%)	N/A	N/A	Clear Space to XWalk (in)	N/A
N/A	Any Obstructions?	N/A	N/A	Storm Grate/Utility Hazard?	N/A
	Obstruction Type			Storm Grate/Utility Type	
		N/A			N/A
		Yes		Surface Condition? (G/P)	Good

**Remove & Replace Entire Ramp.**
