Access Compliance Report

Public Rights-of-Way

(Curb Ramps)

Intersection ID: 15515	Main Street: BERKSHIRE_RD	Cross Street: LAWNDAL RD	Location:	N
ADA ID: 2DBBC49D8466	Ramp Type: PerpDiag	Initial Pass/Fail: Fail	Overall Compliance: No	Severity Score: 48.75
Codes/Mitigation Info/Possible Solution		Field Measurements/Component Compliance

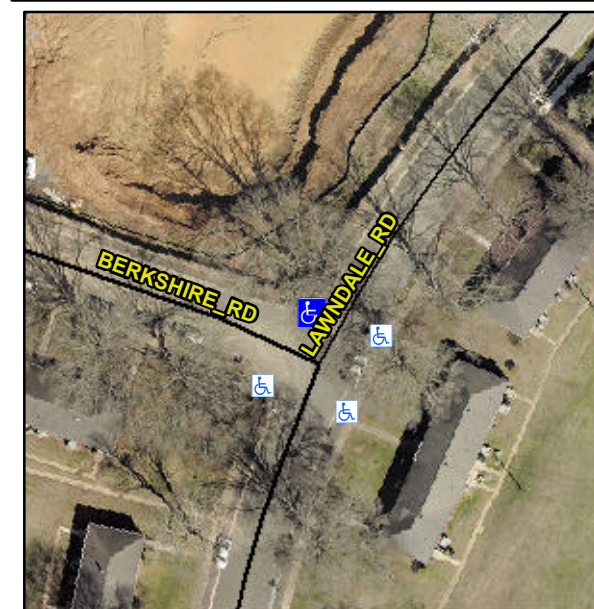
Not Found, R304.5.1, R304.2.2, R302.7

Compliance	Description	Data	Compliance	Description	Data
N/A	Ramp Length (in)	46.0	No	Ramp Slope (%)	13.2
No	Ramp Width (in)	45.0	Yes	Ramp XSlope (%)	1.9
N/A	Flare Type LT	N/A	N/A	Flare Type RT	N/A
N/A	Flare Slope LT (%)	N/A	N/A	Flare Slope RT (%)	N/A
N/A	Flare Traversable LT?	N/A	N/A	Flare Traversable RT?	N/A
N/A	Landing Length (in)	N/A	N/A	DWS Provided?	N/A
N/A	Landing Width (in)	N/A	N/A	DWS Contrast?	N/A
N/A	Landing Slope (%)	N/A	N/A	DWS Length (in)	N/A
N/A	Landing X Slope (%)	N/A	N/A	DWS Full Width?	N/A
N/A	Landing Curb? (Y/N)	N/A	N/A	DWS Offset (in)	N/A
N/A	Shared Landing?	N/A			
N/A	Gutter Ponding?	N/A	N/A	Gutter Slope (%)	N/A
N/A	Gutter Lip Ht (in)	N/A	N/A	Gutter X Slope (%)	N/A
N/A	Painted X Walk1?	No	N/A	Painted X Walk2?	No
	X Walk 1 Direction	To SW		X Walk 2 Direction	To SE
N/A	X Walk 1 Width (in)	N/A	N/A	X Walk 2 Width (in)	N/A
	X Walk 1 Slope (%)	9.0		X Walk 2 Slope (%)	4.9
	X Walk 1 X Slope (%)	1.0		X Walk 2 X Slope (%)	2.3

N/A	Ramp inside XWalk1?	N/A	N/A	Ramp inside XWalk2?	N/A
	Road Slope (%)	2.8	N/A	Clear Space?	N/A
	Road X Slope (%)	4.5	N/A	Clear Space to XWalk (in)	N/A
N/A	Any Obstructions?	N/A	N/A	Storm Grate/Utility Hazard?	N/A
	Obstruction Type			Storm Grate/Utility Type	
		N/A			N/A
		No		Surface Condition? (G/P)	Poor

Possible Solutions:

Remove & Replace Curb Ramp With Two New Directional Ramps or Equivalent.
