# Access Compliance Report

## Public Rights-of-Way

### (Curb Ramps)

| Intersection ID: 45761 | Main Street: SOLACE_CT | Cross Street: GRANDEUR_RD | Location: SE |

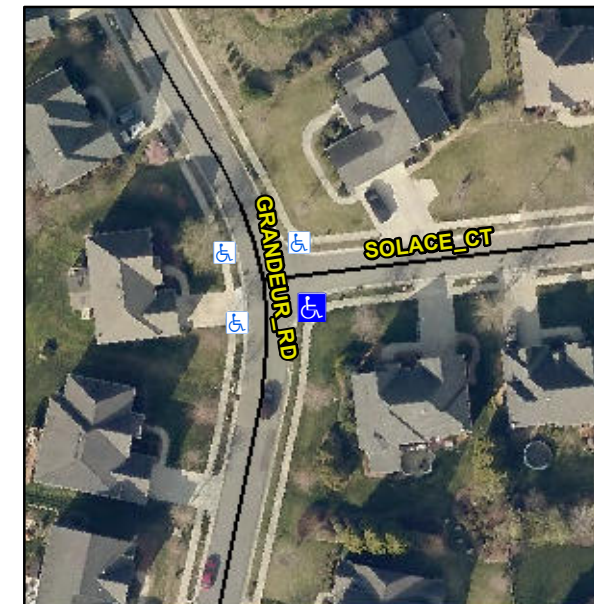
| ADA ID: 2DBD3A28DEA2 | Ramp Type: PerpDiag | Initial Pass/Fail: Fail | Overall Compliance: No |

**Not Found, R304.5.1, R304.2.2**

| Compliance | Description | Data | Compliance | Description | Data |
|---|---|---|---|---|---|
| N/A | Ramp Length (in) | 48.0 | No | Ramp Slope (%) | 11.7 |
| No | Ramp Width (in) | 47.0 | Yes | Ramp XSlope (%) | 0.9 |

**Remove & Replace Curb Ramp With Two New Directional Ramps or Equivalent.**
