Access Compliance Report

Public Rights-of-Way

(Curb Ramps)

Intersection ID: 44481	Main Street: CHALKSTONE_RD	Cross Street: REDDING_GLEN_AV	Location: SE
ADA ID: 2DD1F2799344	Ramp Type: BlendTrans1	Initial Pass/Fail: Fail	Overall Compliance: No
Severity Score: 12.5			
Codes/Mitigation Info/Possible Solution		Field Measurements/Component Compliance

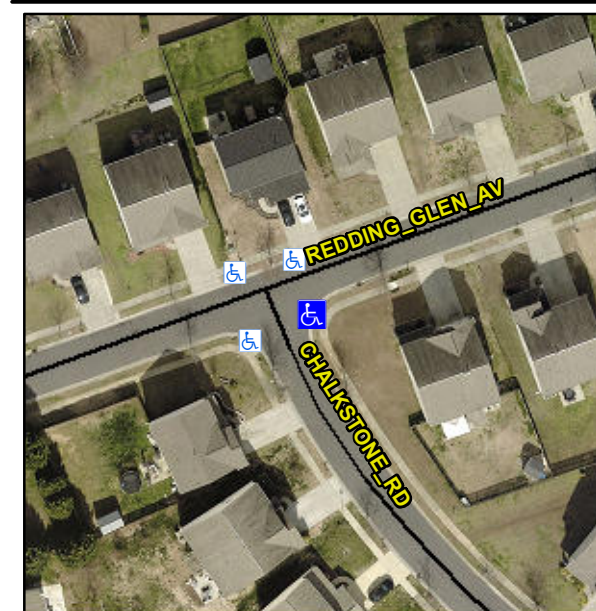
Not Found, R304.5.3

Compliance	Description	Data	Compliance	Description	Data
N/A	Ramp Length (in)	46.0	Yes	BlendTrans Slope (%)	3.6
Yes	Ramp Width (in)	48.0	No	BlendTrans XSlope (%)	6.9
N/A	Flare Type LT	N/A	N/A	Flare Type RT	N/A
N/A	Flare Slope LT (%)	N/A	N/A	Flare Slope RT (%)	N/A
N/A	Flare Traversable LT?	N/A	N/A	Flare Traversable RT?	N/A
N/A	Landing Length (in)	N/A	N/A	DWS Provided?	N/A
N/A	Landing Width (in)	N/A	N/A	DWS Contrast?	N/A
N/A	Landing Slope (%)	N/A	N/A	DWS Length (in)	N/A
N/A	Landing X Slope (%)	N/A	N/A	DWS Full Width?	N/A
N/A	Landing Curb? (Y/N)	N/A	N/A	DWS Offset (in)	N/A
N/A	Shared Landing?	N/A			
N/A	Gutter Ponding?	N/A	N/A	Gutter Slope (%)	N/A
N/A	Gutter Lip Ht (in)	N/A	N/A	Gutter X Slope (%)	N/A
N/A	Painted X Walk1?	No	N/A	Painted X Walk2?	No
	X Walk 1 Direction	To N		X Walk 2 Direction	To W
	X Walk 1 Width (in)	N/A		X Walk 2 Width (in)	N/A
	X Walk 1 Slope (%)	3.1		X Walk 2 Slope (%)	0.5
	X Walk 1 X Slope (%)	2.8		X Walk 2 X Slope (%)	1.9

N/A	Ramp inside XWalk1?	N/A	N/A	Ramp inside XWalk2?	N/A
	Road Slope (%)	2.8		Clear Space?	N/A
	Road X Slope (%)	1.2	N/A	Clear Space to XWalk (in)	N/A
N/A	Any Obstructions?	N/A	N/A	Storm Grate/Utility Hazard?	N/A
	Obstruction Type			Storm Grate/Utility Type	
		N/A			N/A
			Yes	Surface Condition? (G/P)	Good
			No	Curb Slope (%)	22.2

Possible Solutions:

Remove & Replace Curb Ramp With Two New Directional Ramps or Equivalent.
