# Access Compliance Report

## Public Rights-of-Way

### (Curb Ramps)

Intersection ID: N/A	Main Street: WALNUT_LOOP_RD	Cross Street: WOODBINE_WALK_RD	Location: NW
ADA ID: 2DDCB332A1D4	Ramp Type: Perp	Initial Pass/Fail: Fail	Overall Compliance: No
Severity Score: 13.75			
Codes/Mitigation Info/Possible Solution		Field Measurements/Component Compliance

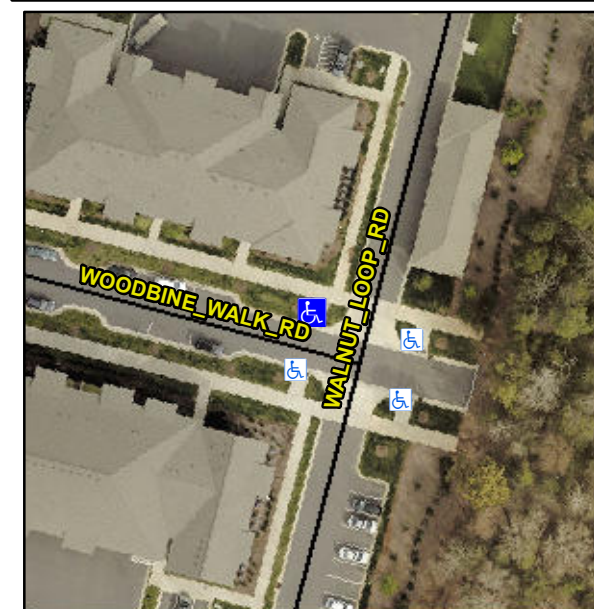
**R304.2.2, R304.5.3**

Compliance	Description	Data	Compliance	Description	Data
N/A	Ramp Length (in)	82.0	No	Ramp Slope (%)	8.6
Yes	Ramp Width (in)	94.0	No	Ramp XSlope (%)	2.9
N/A	Flare Type LT	N/A	N/A	Flare Type RT	N/A
N/A	Flare Slope LT (%)	N/A	N/A	Flare Slope RT (%)	N/A
N/A	Flare Traversable LT?	N/A	N/A	Flare Traversable RT?	N/A
N/A	Landing Length (in)	N/A	N/A	DWS Provided?	N/A
N/A	Landing Width (in)	N/A	N/A	DWS Contrast?	N/A
N/A	Landing Slope (%)	N/A	N/A	DWS Length (in)	N/A
N/A	Landing X Slope (%)	N/A	N/A	DWS Full Width?	N/A
N/A	Landing Curb? (Y/N)	N/A	N/A	DWS Offset (in)	N/A
N/A	Shared Landing?	N/A			
N/A	Gutter Ponding?	N/A	N/A	Gutter Slope (%)	N/A
N/A	Gutter Lip Ht (in)	N/A	N/A	Gutter X Slope (%)	N/A
N/A	Painted X Walk1?	No	N/A	Painted X Walk2?	N/A
	X Walk 1 Direction	To SW		X Walk 2 Direction	N/A
N/A	X Walk 1 Width (in)	N/A	N/A	X Walk 2 Width (in)	N/A
	X Walk 1 Slope (%)	0.8		X Walk 2 Slope (%)	N/A
	X Walk 1 X Slope (%)	1.9		X Walk 2 X Slope (%)	N/A

N/A	Ramp inside XWalk1?	N/A	N/A	Ramp inside XWalk2?	N/A
	Road Slope (%)	N/A	N/A	Clear Space?	N/A
	Road X Slope (%)	N/A	N/A	Clear Space to XWalk (in)	N/A
N/A	Any Obstructions?	N/A	N/A	Storm Grate/Utility Hazard?	N/A
	Obstruction Type			Storm Grate/Utility Type	
		N/A			N/A
		Yes		Surface Condition? (G/P)	Good

**Remove & Replace Entire Ramp.**

Total Cost: \$ 1850.00
