# Access Compliance Report

## Public Rights-of-Way

### (Curb Ramps)

Intersection ID: 14909	Main Street: MANCHESTER_DR	Cross Street: PENROSE_LN	Location: SW
ADA ID: 2DDCFE6FE0C8	Ramp Type: PerpDiag	Initial Pass/Fail: Fail	Overall Compliance: No
Codes/Mitigation Info/Possible Solution		Field Measurements/Component Compliance	
Severity Score: 21.25

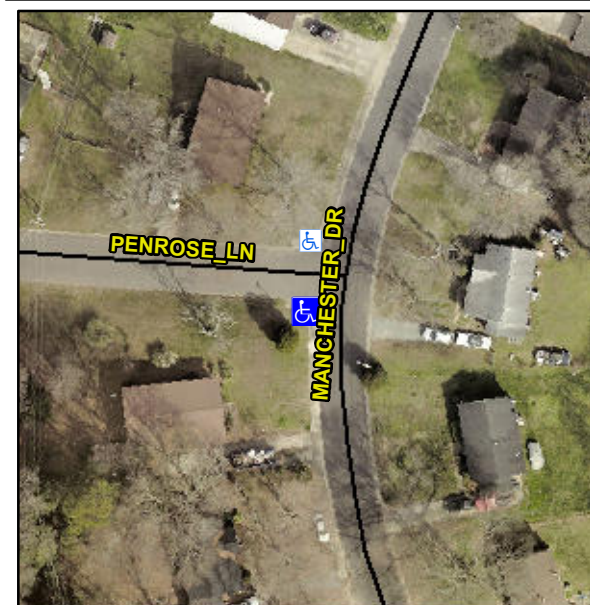
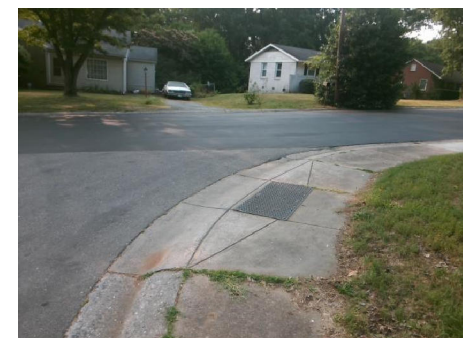
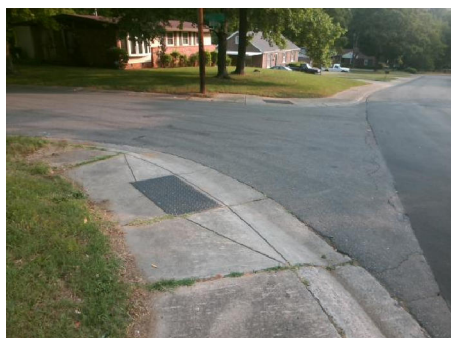
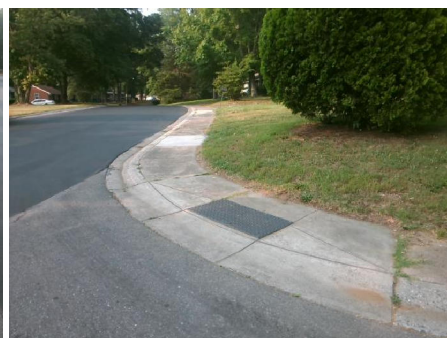
**Not Found, R304.5.1, R304.5.3**

Compliance	Description	Data	Compliance	Description	Data
N/A	Ramp Length (in)	51.0	Yes	Ramp Slope (%)	5.3
No	Ramp Width (in)	45.0	No	Ramp XSlope (%)	5.7
N/A	Flare Type LT	N/A	N/A	Flare Type RT	N/A
N/A	Flare Slope LT (%)	N/A	N/A	Flare Slope RT (%)	N/A
N/A	Flare Traversable LT?	N/A	N/A	Flare Traversable RT?	N/A
N/A	Landing Length (in)	N/A	N/A	DWS Provided?	N/A
N/A	Landing Width (in)	N/A	N/A	DWS Contrast?	N/A
N/A	Landing Slope (%)	N/A	N/A	DWS Length (in)	N/A
N/A	Landing X Slope (%)	N/A	N/A	DWS Full Width?	N/A
N/A	Landing Curb? (Y/N)	N/A	N/A	DWS Offset (in)	N/A
N/A	Shared Landing?	N/A			
N/A	Gutter Ponding?	N/A	N/A	Gutter Slope (%)	N/A
N/A	Gutter Lip Ht (in)	N/A	N/A	Gutter X Slope (%)	N/A
N/A	Painted X Walk1?	No	N/A	Painted X Walk2?	No
	X Walk 1 Direction	To E		X Walk 2 Direction	To N
N/A	X Walk 1 Width (in)	N/A	N/A	X Walk 2 Width (in)	N/A
	X Walk 1 Slope (%)	2.0		X Walk 2 Slope (%)	6.0
	X Walk 1 X Slope (%)	5.7		X Walk 2 X Slope (%)	2.7

N/A	Ramp inside XWalk1?	N/A	N/A	Ramp inside XWalk2?	N/A
	Road Slope (%)	5.6	N/A	Clear Space?	N/A
	Road X Slope (%)	0.2	N/A	Clear Space to XWalk (in)	N/A
N/A	Any Obstructions?	N/A	N/A	Storm Grate/Utility Hazard?	N/A
	Obstruction Type			Storm Grate/Utility Type	
		N/A			N/A
			Yes	Surface Condition? (G/P)	Good

**Remove & Replace Curb Ramp With Two New Directional Ramps or Equivalent.**
