Access Compliance Report

Public Rights-of-Way (Curb Ramps)

Intersection ID: N/A	Main Street: HATTON_CROSS_DR	Cross Street: DERWENT_CT	Location: NE
ADA ID: 2DE4DC34B687	Ramp Type: Directional1	Initial Pass/Fail: Fail	Overall Compliance: No
		Severity Score: 1.25

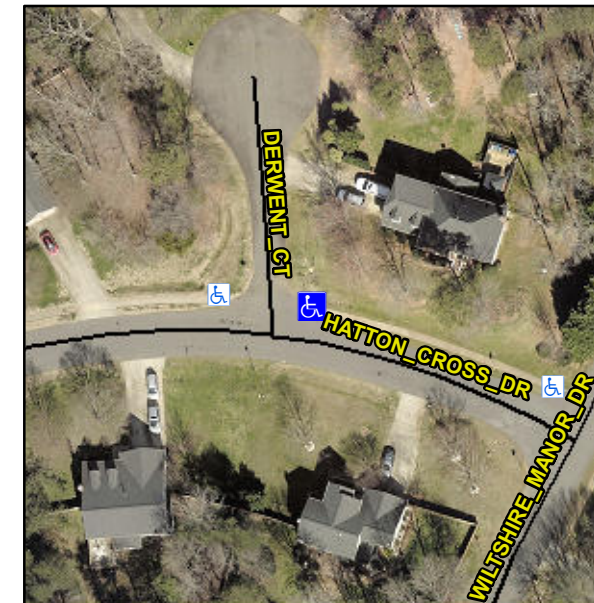
Compliance	Description	Data	Compliance	Description	Data
N/A	Ramp Length (in)	48.0	N/A	Grade Break?	N/A
Yes	Ramp Width (in)	48.0	N/A	Grade Break Slope (%)	0.0
Yes	Ramp Slope (%)	3.2	N/A	Grade Break XSlope (%)	0.0
No	Ramp XSlope (%)	2.2			
N/A	Flare Type LT	N/A	N/A	Flare Type RT	N/A
N/A	Flare Slope LT (%)	N/A	N/A	Flare Slope RT (%)	0.0
N/A	Flare Traversable LT?	N/A	N/A	Flare Traversable RT?	N/A
N/A	Landing Length (in)	0.0	N/A	DWS Provided?	N/A
N/A	Landing Width (in)	0.0	N/A	DWS Contrast?	N/A
N/A	Landing Slope (%)	0.0	N/A	DWS Length (in)	N/A
N/A	Landing X Slope (%)	0.0	N/A	DWS Full Width?	N/A
N/A	Landing Curb? (Y/N)	N/A	N/A	DWS Offset LT (in)	N/A
N/A	Shared Landing?	N/A	N/A	DWS Offset RT (in)	N/A
N/A	Gutter Ponding?	0.0	N/A	Gutter Slope (%)	N/A
N/A	Gutter Lip Ht (in)	0.0	N/A	Gutter X Slope (%)	N/A
N/A	Painted X Walk1?	No		Road Slope (%)	1.4
	X Walk 1 Direction	To W		Road X Slope (%)	3.4
	X Walk 1 Width (in)	N/A		Clear Space?	N/A

X Walk 1 Slope (%)	1.4	N/A	Clear Space to XWalk (in)	N/A
	X Walk 1 X Slope (%)	3.4	N/A	Storm Grate/Utility Hazard?	N/A
N/A	Ramp inside XWalk1?	N/A		Storm Grate/Utility Type	
N/A	Any Obstructions?	N/A			N/A
	Obstruction Type		Yes	Surface Condition? (G/P)	Good
			N/A	Curb Slope (%)	4.2

Possible Solutions:

Remove & Replace Entire Ramp.

R304.5.3

\$ 1600.00
