# Access Compliance Report

## Public Rights-of-Way

### (Curb Ramps)

Intersection ID: 17836	Main Street: NORMANDY_RD	Cross Street: PENDER_PL	Location: NE
ADA ID: 2DEB4B3D760B	Ramp Type: PerpDiag	Initial Pass/Fail: Fail	Overall Compliance: No
Severity Score: 22.5			
Codes/Mitigation Info/Possible Solution		Field Measurements/Component Compliance

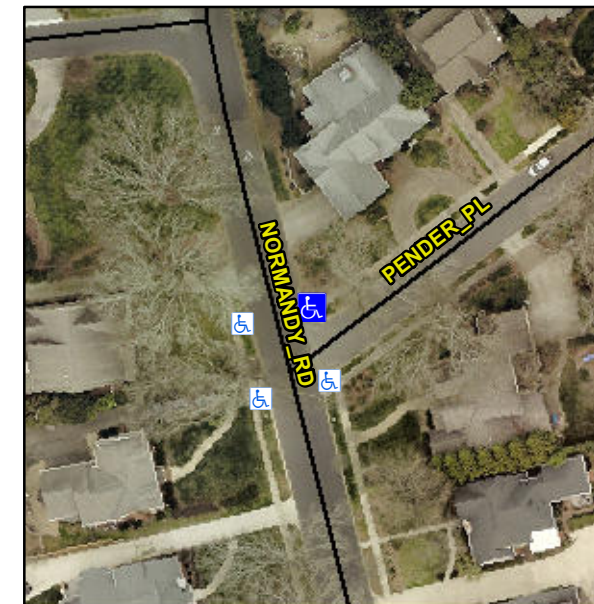
**Not Found, R304.5.1, R304.2.2, R304.5.3**

Compliance	Description	Data	Compliance	Description	Data
N/A	Ramp Length (in)	61.0	No	Ramp Slope (%)	8.4
No	Ramp Width (in)	47.0	No	Ramp XSlope (%)	2.7
N/A	Flare Type LT	N/A	N/A	Flare Type RT	N/A
N/A	Flare Slope LT (%)	N/A	N/A	Flare Slope RT (%)	N/A
N/A	Flare Traversable LT?	N/A	N/A	Flare Traversable RT?	N/A
N/A	Landing Length (in)	N/A	N/A	DWS Provided?	N/A
N/A	Landing Width (in)	N/A	N/A	DWS Contrast?	N/A
N/A	Landing Slope (%)	N/A	N/A	DWS Length (in)	N/A
N/A	Landing X Slope (%)	N/A	N/A	DWS Full Width?	N/A
N/A	Landing Curb? (Y/N)	N/A	N/A	DWS Offset (in)	N/A
N/A	Shared Landing?	N/A			
N/A	Gutter Ponding?	N/A	N/A	Gutter Slope (%)	N/A
N/A	Gutter Lip Ht (in)	N/A	N/A	Gutter X Slope (%)	N/A
N/A	Painted X Walk1?	No	N/A	Painted X Walk2?	No
	X Walk 1 Direction	To W		X Walk 2 Direction	To S
N/A	X Walk 1 Width (in)	N/A	N/A	X Walk 2 Width (in)	N/A
	X Walk 1 Slope (%)	8.2		X Walk 2 Slope (%)	1.8
	X Walk 1 X Slope (%)	6.5		X Walk 2 X Slope (%)	0.7

N/A	Ramp inside XWalk1?	N/A	N/A	Ramp inside XWalk2?	N/A
	Road Slope (%)	2.7	N/A	Clear Space?	N/A
	Road X Slope (%)	2.4	N/A	Clear Space to XWalk (in)	N/A
N/A	Any Obstructions?	N/A	N/A	Storm Grate/Utility Hazard?	N/A
	Obstruction Type			Storm Grate/Utility Type	
		N/A			N/A
			Yes	Surface Condition? (G/P)	Good

**Remove & Replace Curb Ramp With Two New Directional Ramps or Equivalent.**
