# Access Compliance Report

## Public Rights-of-Way

### (Curb Ramps)

| Intersection ID: 30686 | Main Street: LANCASTER_HY | Cross Street: COPPER_MOUNTAIN_BV | Location: SW |

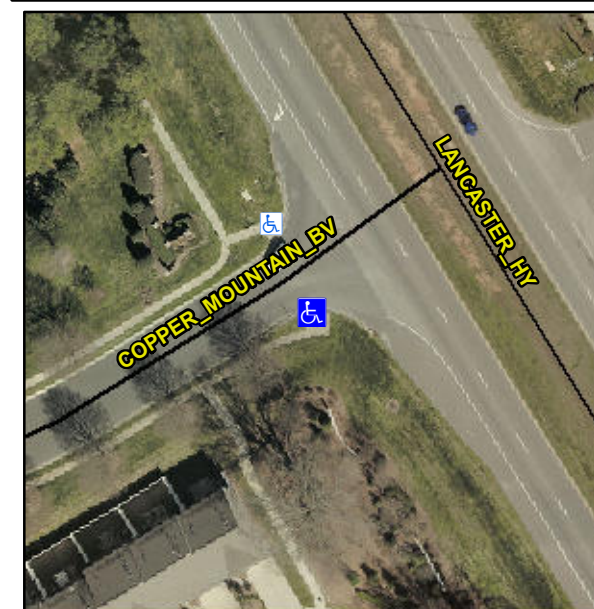
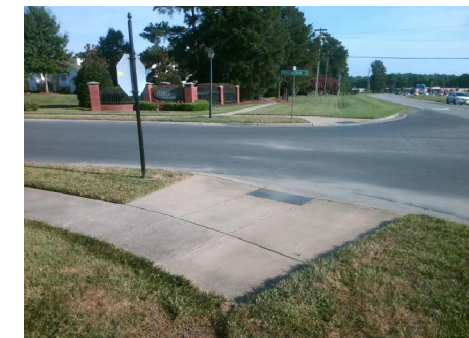
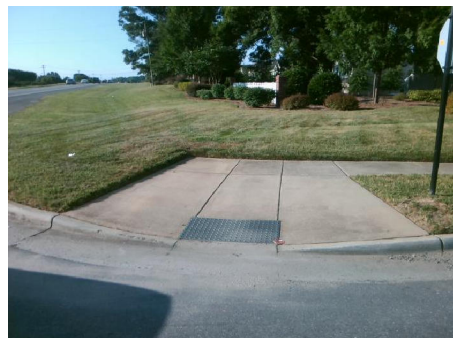
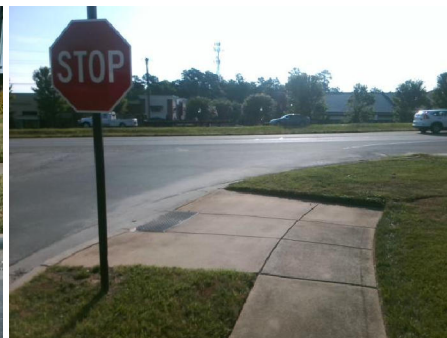
| ADA ID: 2DECCC432119 | Ramp Type: Perp | Initial Pass/Fail: Fail | Overall Compliance: No |

**Not Found, R304.5.1, R304.2.2**

| Compliance | Description | Data | Compliance | Description | Data |
|---|---|---|---|---|---|
| N/A | Ramp Length (in) | 100.0 | No | Ramp Slope (%) | 9.0 |
| No | Ramp Width (in) | 39.0 | Yes | Ramp XSlope (%) | 1.3 |

**Remove & Replace Entire Ramp.**
