# Access Compliance Report

## Public Rights-of-Way

### (Curb Ramps)

Intersection ID: 26367	Main Street: BEVINGTON_PL	Cross Street: GLYNMOOR_LAKES_DR	Location: SW
ADA ID: 2DFCA02D4B7D	Ramp Type: BlendTrans2	Initial Pass/Fail: Fail	Overall Compliance: No
		Severity Score: 8.75

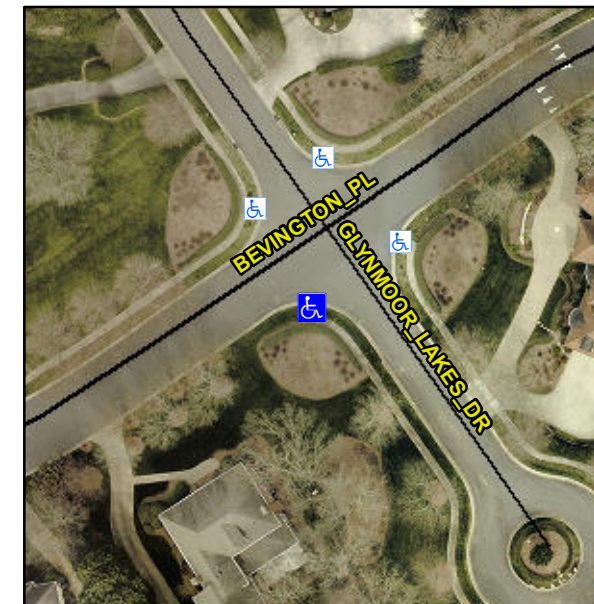
Compliance	Description	Data	Compliance	Description	Data
N/A	Ramp Length (in)	122.0	Yes	BlendTrans Slope (%)	4.1
No	Ramp Width (in)	38.0	Yes	BlendTrans XSlope (%)	1.2
N/A	Flare Type LT	N/A	N/A	Flare Type RT	N/A
N/A	Flare Slope LT (%)	N/A	N/A	Flare Slope RT (%)	N/A
N/A	Flare Traversable LT?	N/A	N/A	Flare Traversable RT?	N/A
N/A	Landing Length (in)	N/A	N/A	DWS Provided?	N/A
N/A	Landing Width (in)	N/A	N/A	DWS Contrast?	N/A
N/A	Landing Slope (%)	N/A	N/A	DWS Length (in)	N/A
N/A	Landing X Slope (%)	N/A	N/A	DWS Full Width?	N/A
N/A	Landing Curb? (Y/N)	N/A	N/A	DWS Offset (in)	N/A
N/A	Shared Landing?	N/A			
N/A	Gutter Ponding?	N/A	N/A	Gutter Slope (%)	N/A
N/A	Gutter Lip Ht (in)	N/A	N/A	Gutter X Slope (%)	N/A
N/A	Painted X Walk1?	No	N/A	Painted X Walk2?	No
	X Walk 1 Direction	To NE		X Walk 2 Direction	To NW
	X Walk 1 Width (in)	N/A		X Walk 2 Width (in)	N/A
	X Walk 1 Slope (%)	0.8		X Walk 2 Slope (%)	0.1
	X Walk 1 X Slope (%)	1.1		X Walk 2 X Slope (%)	1.4

N/A	Ramp inside XWalk1?	N/A	N/A	Ramp inside XWalk2?	N/A
	Road Slope (%)	0.9		Clear Space?	N/A
	Road X Slope (%)	0.1	N/A	Clear Space to XWalk (in)	N/A
N/A	Any Obstructions?	N/A	N/A	Storm Grate/Utility Hazard?	N/A
	Obstruction Type			Storm Grate/Utility Type	
		N/A			N/A
			Yes	Surface Condition? (G/P)	Good
			N/A	Curb Slope (%)	4.7

**Remove & Replace Curb Ramp With Two New Directional Ramps or Equivalent.**

**R304.5.1**

Total Cost: \$ 3200.00
