# Access Compliance Report

## Public Rights-of-Way

| Intersection ID: 25815 | Main Street: REA_RD | Cross Street: PINEVILLE-MATTHEWS_RD | Location: SE |
| ADA ID: 2DFEE19702EF | Ramp Type: Perp | Initial Pass/Fail: Fail | Overall Compliance: No |

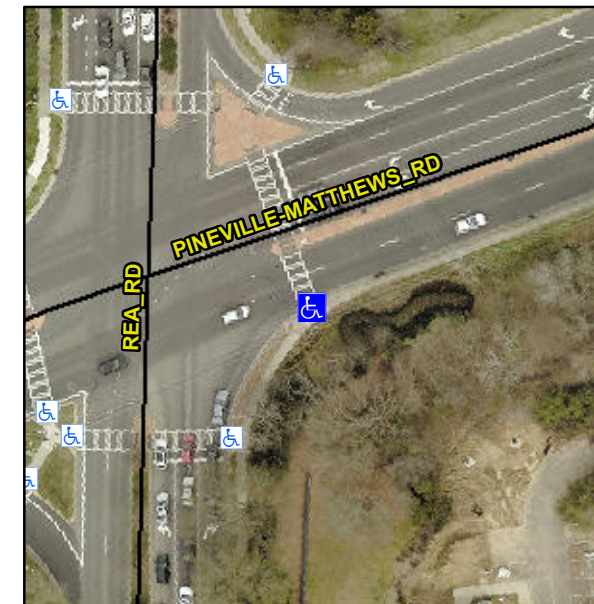
| Severity Score: 12.5 | | | |

**Not Found, R304.2.2**

| Compliance | Description | Data | Compliance | Description | Data |
|---|---|---|---|---|---|
| N/A | Ramp Length (in) | 45.0 | No | Ramp Slope (%) | 8.9 |

**Remove & Replace Entire Ramp.**

Total Cost: \$ 1850.00

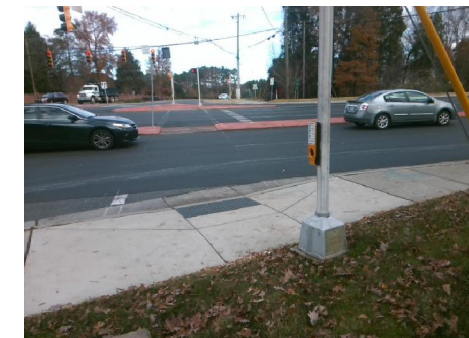
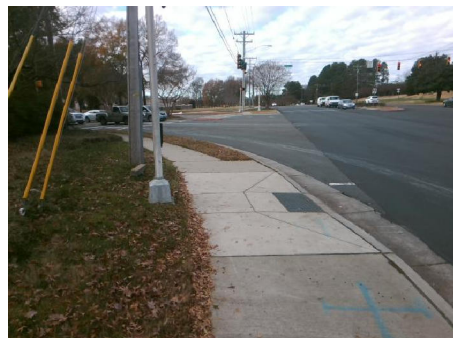
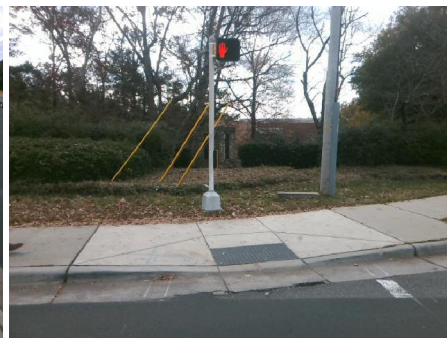
| Compliance | Description | Data | Compliance | Description | Data |
|---|---|---|---|---|---|
| N/A | Painted X Walk1? | No | N/A | Painted X Walk2? | N/A |
| | | | Yes | Surface Condition? (G/P) | Good |
