Access Compliance Report

Public Rights-of-Way

(Curb Ramps)

| Intersection ID: 45967 | Main Street: FOREST_MEADOW_DR | Cross Street: IDLEWILD_RD_NORTH | Location: SW |

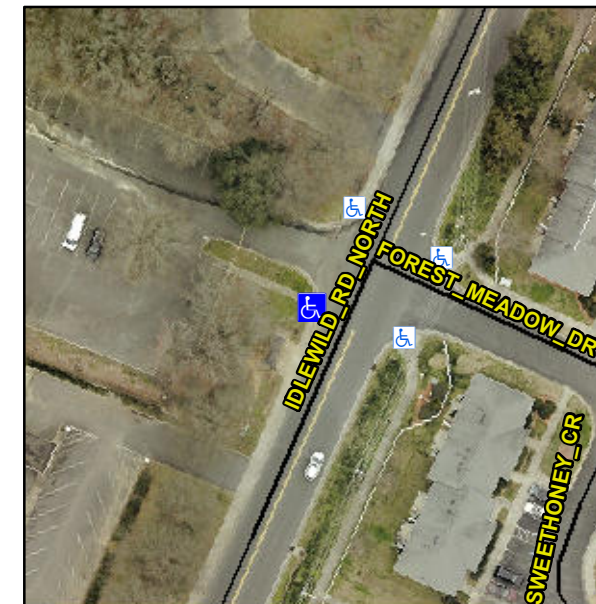
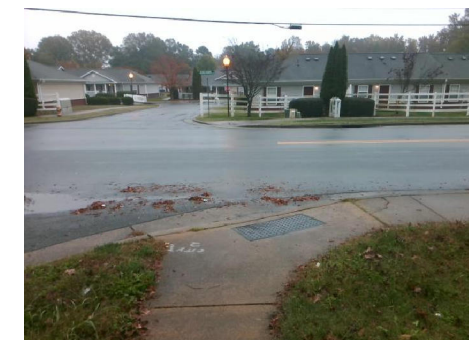
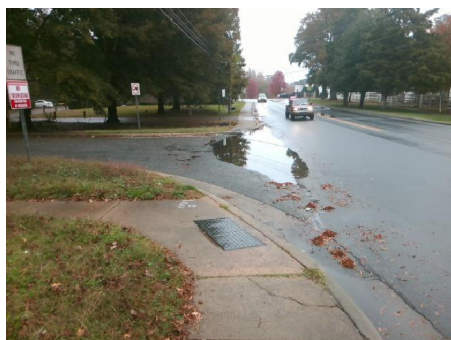
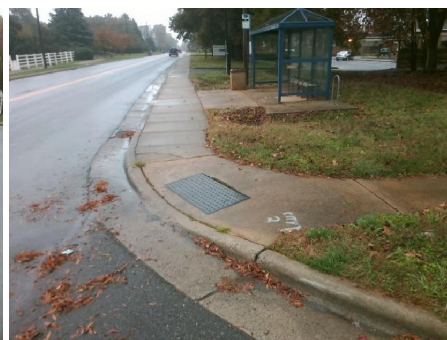
| ADA ID: 2E0BD3F91FF9 | Ramp Type: PerpDiag | Initial Pass/Fail: Fail | Overall Compliance: No |

R304.2.2

| Compliance | Description | Data | Compliance | Description | Data |
|---|---|---|---|---|---|
| N/A | Ramp Length (in) | 57.0 | No | Ramp Slope (%) | 9.3 |

Remove & Replace Curb Ramp With Two New Directional Ramps or Equivalent.

Total Cost: \$ **3200.00**
