Access Compliance Report

Public Rights-of-Way

(Curb Ramps)

Intersection ID: 10020376	Main Street: BALLANTYNE CORPORATE PL	Cross Street: N/A	Location: NW
ADA ID: 2E1AAD9B8B11	Ramp Type: Perp	Initial Pass/Fail: Fail	Overall Compliance: No
		Severity Score: 10

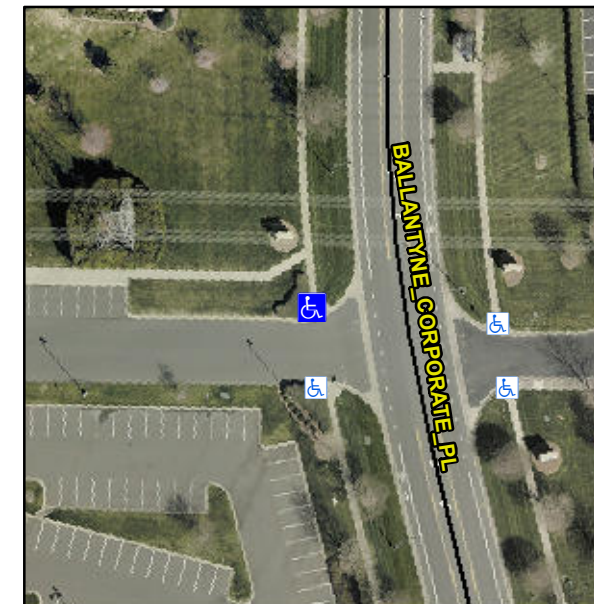
Not Found, R304.5.1, R304.5.3

Compliance	Description	Data	Compliance	Description	Data
N/A	Ramp Length (in)	59.0	Yes	Ramp Slope (%)	6.0
No	Ramp Width (in)	40.0	No	Ramp XSlope (%)	3.9
N/A	Flare Type LT	N/A	N/A	Flare Type RT	N/A
N/A	Flare Slope LT (%)	N/A	N/A	Flare Slope RT (%)	N/A
N/A	Flare Traversable LT?	N/A	N/A	Flare Traversable RT?	N/A
N/A	Landing Length (in)	N/A	N/A	DWS Provided?	N/A
N/A	Landing Width (in)	N/A	N/A	DWS Contrast?	N/A
N/A	Landing Slope (%)	N/A	N/A	DWS Length (in)	N/A
N/A	Landing X Slope (%)	N/A	N/A	DWS Full Width?	N/A
N/A	Landing Curb? (Y/N)	N/A	N/A	DWS Offset (in)	N/A
N/A	Shared Landing?	N/A			
N/A	Gutter Ponding?	N/A	N/A	Gutter Slope (%)	N/A
N/A	Gutter Lip Ht (in)	N/A	N/A	Gutter X Slope (%)	N/A
N/A	Painted X Walk1?	No	N/A	Painted X Walk2?	N/A
	X Walk 1 Direction	To S		X Walk 2 Direction	N/A
N/A	X Walk 1 Width (in)	N/A	N/A	X Walk 2 Width (in)	N/A
	X Walk 1 Slope (%)	0.1		X Walk 2 Slope (%)	N/A
	X Walk 1 X Slope (%)	1.6		X Walk 2 X Slope (%)	N/A

N/A	Ramp inside XWalk1?	N/A	N/A	Ramp inside XWalk2?	N/A
	Road Slope (%)	N/A	N/A	Clear Space?	N/A
	Road X Slope (%)	N/A	N/A	Clear Space to XWalk (in)	N/A
N/A	Any Obstructions?	N/A	N/A	Storm Grate/Utility Hazard?	N/A
	Obstruction Type			Storm Grate/Utility Type	
		N/A			N/A
			Yes	Surface Condition? (G/P)	Good

Remove & Replace Entire Ramp.
