# Access Compliance Report

## Public Rights-of-Way

### (Curb Ramps)

| Intersection ID: 43685 | Main Street: HARLINGTON_LN | Cross Street: TODDINGTON_LN | Location: SE |

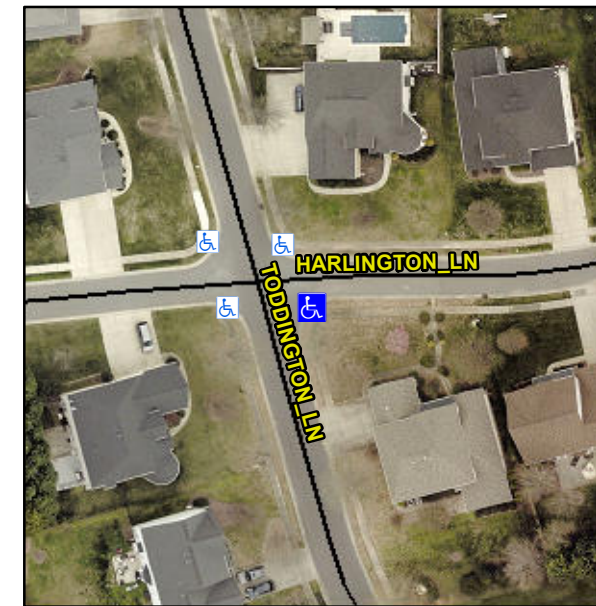
**Not Found, R304.5.1, R304.5.3**

| Compliance | Description | Data | Compliance | Description | Data |
|---|---|---|---|---|---|
| N/A | Ramp Length (in) | 53.0 | Yes | BlendTrans Slope (%) | 2.1 |
| No | Ramp Width (in) | 35.5 | No | BlendTrans XSlope (%) | 2.3 |
| | | | No | Curb Slope (%) | 11.4 |

Possible Solutions:

**Remove & Replace Curb Ramp With Two New Directional Ramps or Equivalent.**

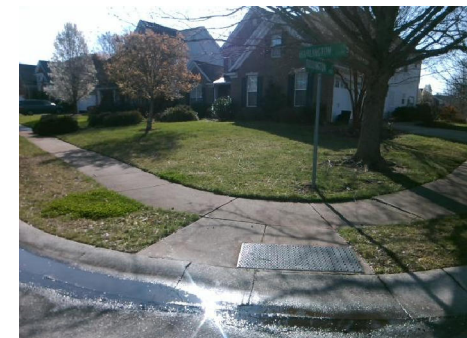
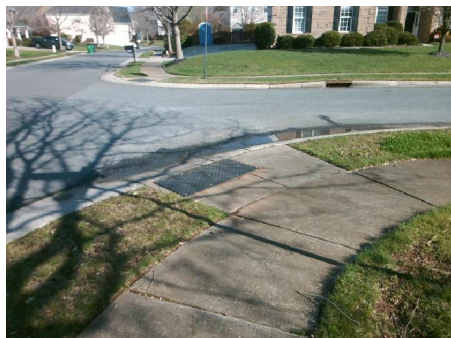
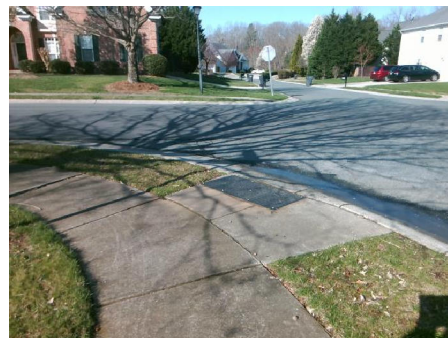
| ADA ID: 2E1CFA759B89 | Ramp Type: BlendTrans1 | Initial Pass/Fail: Fail | Overall Compliance: No |
| Severity Score: 18.75 | | | |
