# Access Compliance Report

## Public Rights-of-Way

| Intersection ID: 27595 | Main Street: BALLANTYNE COMMONS PY | Cross Street: BALLANTYNE MEADOWS DR | Location: SE |
| ADA ID: 2E1E1A5B207F | Ramp Type: BlendTrans2 | Initial Pass/Fail: Fail | Overall Compliance: No |

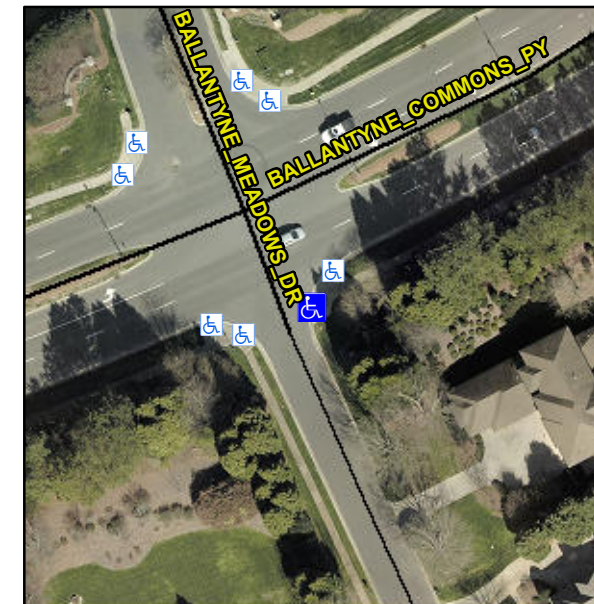
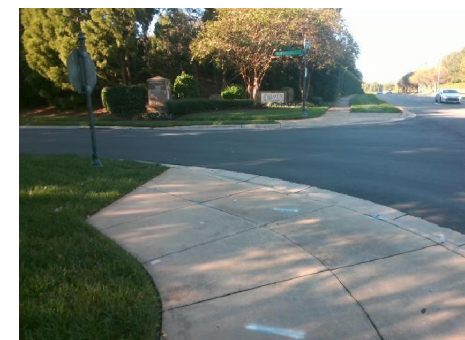
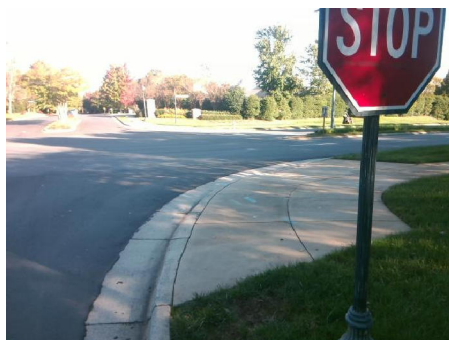
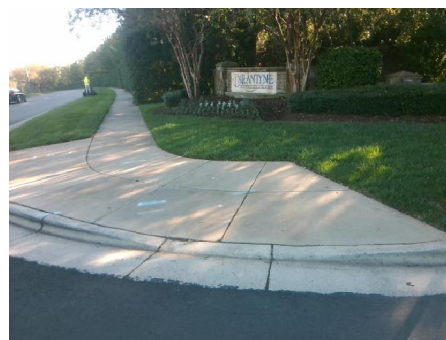
| | | Severity Score: 10 | |

**R304.5.1, R304.5.3**

| Compliance | Description | Data | Compliance | Description | Data |
|---|---|---|---|---|---|
| No | Ramp Width (in) | 44.0 | No | BlendTrans XSlope (%) | 3.7 |

**Remove & Replace Curb Ramp With Two New Directional Ramps or Equivalent.**
