Access Compliance Report

Public Rights-of-Way

(Curb Ramps)

| Intersection ID: 15865 | Main Street: ST_JAMES_PL | Cross Street: STANCILL_PL | Location: NW |

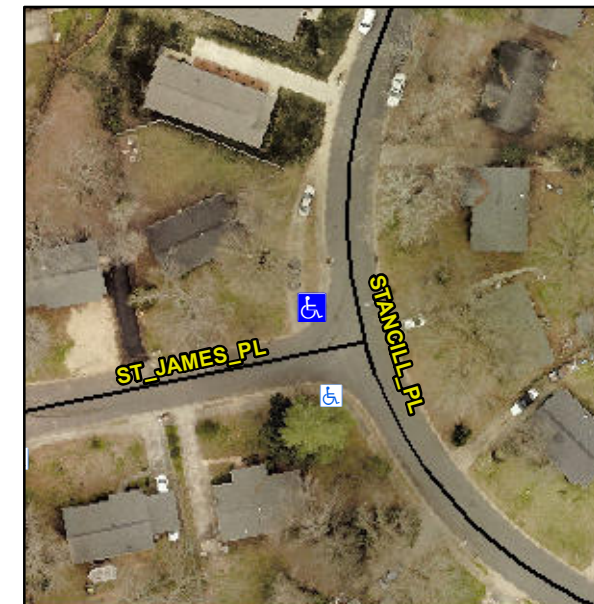
Not Found, R304.5.1, R304.2.2, R304.5.3

| Compliance | Description | Data | Compliance | Description | Data |
|---|---|---|---|---|---|
| N/A | Ramp Length (in) | 48.0 | No | Ramp Slope (%) | 15.3 |
| No | Ramp Width (in) | 42.0 | No | Ramp XSlope (%) | 7.6 |

Possible Solutions:

Remove & Replace Curb Ramp With Two New Directional Ramps or Equivalent.
