# Access Compliance Report

## Public Rights-of-Way

### (Curb Ramps)

| Intersection ID: 31392 | Main Street: COVINGTONWOOD_DR | Cross Street: POINTER_RIDGE_DR | Location: NE |

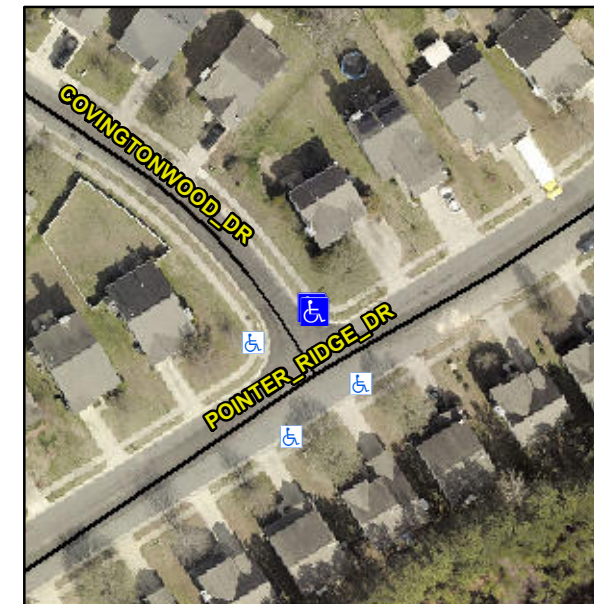
| ADA ID: 2E2DCC84F1C2 | Ramp Type: PerpDiag | Initial Pass/Fail: Fail | Overall Compliance: No |
| Severity Score: 21.25 | | | |

**Not Found, R304.5.1, R304.2.2**

| Compliance | Description | Data | Compliance | Description | Data |
|---|---|---|---|---|---|
| N/A | Ramp Length (in) | 45.0 | No | Ramp Slope (%) | 8.4 |
| No | Ramp Width (in) | 47.0 | Yes | Ramp XSlope (%) | 0.6 |

**Remove & Replace Curb Ramp With Two New Directional Ramps or Equivalent.**

Total Cost: \$ 3200.00
