## Access Compliance Report Public Rights-of-Way (Curb Ramps)

Intersection ID: 15238Main Street: CLANTON\_RDCross Street: MANCHESTER\_DRLocation:SEADA ID: 2E327C69B6B7Ramp Type: ParaDiagInitial Pass/Fail: FailOverall Compliance: NoSeverity Score:35

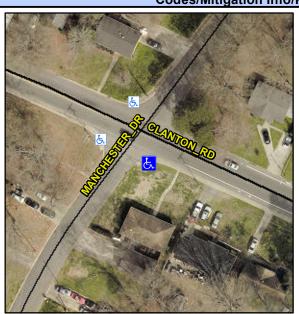
RT RP < 5%

Compliance Description Data			Compliance Description Data		
N/A	Ramp Length LT (in)	24.0	N/A	Ramp Length RT (in)	25.0
No	Ramp Width LT (in)	47.0	No	Ramp Width RT (in)	46.0
No	Ramp Slope LT (%)	16.2	Yes	Ramp Slope RT (%)	4.9
No	Ramp XSlope LT (%)	3.3	No	Ramp XSlope RT (%)	2.6
N/A	Landing Length (in)	N/A	N/A	DWS Provided?	N/A
N/A	Landing Width (in)	N/A	N/A	DWS Contrast?	N/A
N/A	Landing Slope (%)	N/A	N/A	DWS Length (in)	N/A
N/A	Landing X Slope (%)	N/A	N/A	DWS Full Width?	N/A
N/A	Landing Curb? (Y/N)	N/A	N/A	DWS Offset (in)	N/A
N/A	Shared Landing?	N/A			
N/A	Gutter Ponding?	N/A	N/A	Gutter Slope (%)	N/A
N/A	Gutter Lip Ht (in)	N/A	N/A	Gutter X Slope (%)	N/A
N/A	Painted X Walk1?	No	N/A	Painted X Walk2?	No
	X Walk 1 Direction	To NE		X Walk 2 Direction	To NW
N/A	X Walk 1 Width (in)	N/A	N/A	X Walk 2 Width (in)	N/A
	X Walk 1 Slope (%)	5.0		X Walk 2 Slope (%)	2.5
	X Walk 1 X Slope (%)	1.2		X Walk 2 X Slope (%)	6.8
N/A	Ramp inside XWalk1?	N/A	N/A	Ramp inside XWalk2?	N/A

Road Slope (%)	2.4	N/A	Clear Space?	N/A
	Road X Slope (%)	7.6	N/A	Clear Space to XWalk (in)	N/A
N/A	Any Obstructions?	N/A	N/A	Storm Grate/Utility Hazard?	N/A
	Obstruction Type			Storm Grate/Utility Type	
		N/A			N/A
			Yes	Surface Condition? (G/P)	Good
			N/A	Curb Slope (%)	7.0

Remove & Replace Curb Ramp With Two New Directional Ramps or Equivalent.

R304.5.1, R304.3.2, R304.5.3
