# Access Compliance Report

## Public Rights-of-Way

### (Curb Ramps)

Intersection ID: 24436	Main Street: CARMEL_RD	Cross Street: WINGEDFOOT_RD	Location: SE
ADA ID: 2E32A30490C9	Ramp Type: PerpDiag	Initial Pass/Fail: Fail	Overall Compliance: No
Severity Score: 21.25			
Codes/Mitigation Info/Possible Solution		Field Measurements/Component Compliance

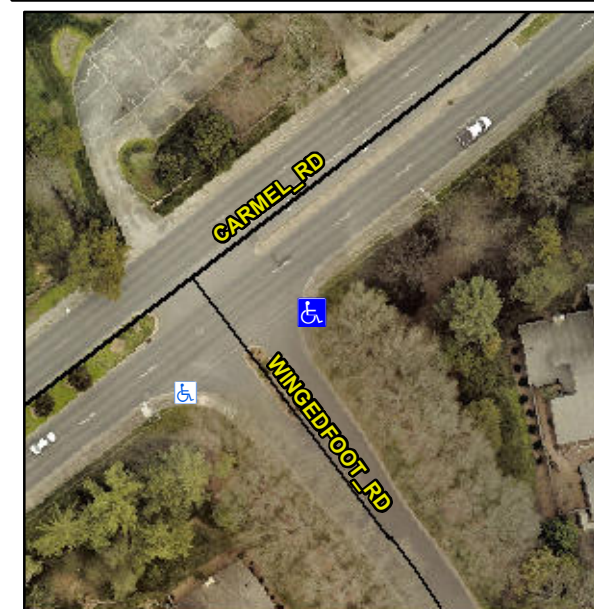
Compliance	Description	Data	Compliance	Description	Data
N/A	Ramp Length (in)	59.0	No	Ramp Slope (%)	9.1
No	Ramp Width (in)	43.0	Yes	Ramp XSlope (%)	0.1
N/A	Flare Type LT	N/A	N/A	Flare Type RT	N/A
N/A	Flare Slope LT (%)	N/A	N/A	Flare Slope RT (%)	N/A
N/A	Flare Traversable LT?	N/A	N/A	Flare Traversable RT?	N/A
N/A	Landing Length (in)	N/A	N/A	DWS Provided?	N/A
N/A	Landing Width (in)	N/A	N/A	DWS Contrast?	N/A
N/A	Landing Slope (%)	N/A	N/A	DWS Length (in)	N/A
N/A	Landing X Slope (%)	N/A	N/A	DWS Full Width?	N/A
N/A	Landing Curb? (Y/N)	N/A	N/A	DWS Offset (in)	N/A
N/A	Shared Landing?	N/A			
N/A	Gutter Ponding?	N/A	N/A	Gutter Slope (%)	N/A
N/A	Gutter Lip Ht (in)	N/A	N/A	Gutter X Slope (%)	N/A
N/A	Painted X Walk1?	No	N/A	Painted X Walk2?	No
	X Walk 1 Direction	To NW		X Walk 2 Direction	To SW
N/A	X Walk 1 Width (in)	N/A	N/A	X Walk 2 Width (in)	N/A
	X Walk 1 Slope (%)	4.8		X Walk 2 Slope (%)	4.3
	X Walk 1 X Slope (%)	0.9		X Walk 2 X Slope (%)	2.7

N/A	Ramp inside XWalk1?	N/A	N/A	Ramp inside XWalk2?	N/A
	Road Slope (%)	3.0	N/A	Clear Space?	N/A
	Road X Slope (%)	6.6	N/A	Clear Space to XWalk (in)	N/A
N/A	Any Obstructions?	N/A	N/A	Storm Grate/Utility Hazard?	N/A
	Obstruction Type			Storm Grate/Utility Type	
		N/A			N/A
		Yes		Surface Condition? (G/P)	Good

Possible Solutions:

**Remove & Replace Curb Ramp With Two New Directional Ramps or Equivalent.**

**R304.5.1, R304.2.2**

Total Cost: \$ 3200.00
