Access Compliance Report

Public Rights-of-Way

(Curb Ramps)

Intersection ID: 50023	Main Street: SPRINGFIELD_GARDENS_DR	Cross Street: WYALONG_DR	Location: SE
ADA ID: 2E3D3356B165	Ramp Type: Perp	Initial Pass/Fail: Fail	Overall Compliance: No
Severity Score: 13.75			
Codes/Mitigation Info/Possible Solution		Field Measurements/Component Compliance

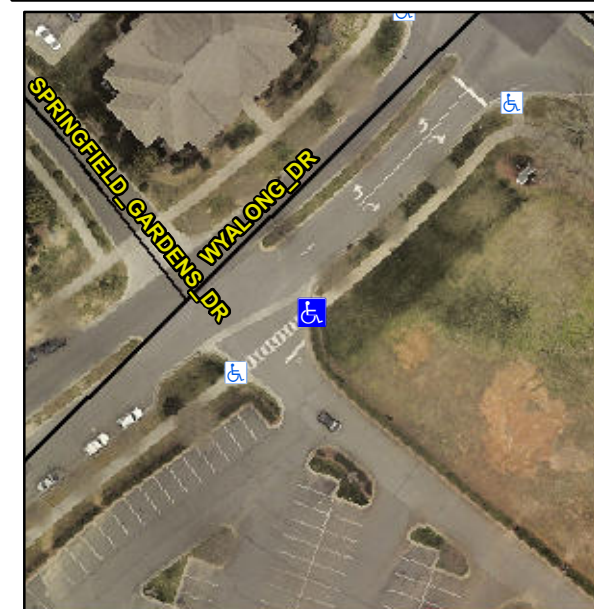
R304.2.2, R304.5.3

Compliance	Description	Data	Compliance	Description	Data
N/A	Ramp Length (in)	90.0	No	Ramp Slope (%)	8.5
Yes	Ramp Width (in)	57.0	No	Ramp XSlope (%)	3.4
N/A	Flare Type LT	N/A	N/A	Flare Type RT	N/A
N/A	Flare Slope LT (%)	N/A	N/A	Flare Slope RT (%)	N/A
N/A	Flare Traversable LT?	N/A	N/A	Flare Traversable RT?	N/A
N/A	Landing Length (in)	N/A	N/A	DWS Provided?	N/A
N/A	Landing Width (in)	N/A	N/A	DWS Contrast?	N/A
N/A	Landing Slope (%)	N/A	N/A	DWS Length (in)	N/A
N/A	Landing X Slope (%)	N/A	N/A	DWS Full Width?	N/A
N/A	Landing Curb? (Y/N)	N/A	N/A	DWS Offset (in)	N/A
N/A	Shared Landing?	N/A			
N/A	Gutter Ponding?	N/A	N/A	Gutter Slope (%)	N/A
N/A	Gutter Lip Ht (in)	N/A	N/A	Gutter X Slope (%)	N/A
N/A	Painted X Walk1?	Yes	N/A	Painted X Walk2?	N/A
	X Walk 1 Direction	To SW		X Walk 2 Direction	N/A
N/A	X Walk 1 Width (in)	72.0	N/A	X Walk 2 Width (in)	N/A
	X Walk 1 Slope (%)	0.5		X Walk 2 Slope (%)	N/A
	X Walk 1 X Slope (%)	0.2		X Walk 2 X Slope (%)	N/A

N/A	Ramp inside XWalk1?	Yes	N/A	Ramp inside XWalk2?	N/A
	Road Slope (%)	N/A	N/A	Clear Space?	N/A
	Road X Slope (%)	N/A	N/A	Clear Space to XWalk (in)	N/A
N/A	Any Obstructions?	N/A	N/A	Storm Grate/Utility Hazard?	N/A
	Obstruction Type			Storm Grate/Utility Type	
		N/A			N/A
		Yes		Surface Condition? (G/P)	Good

Remove & Replace Entire Ramp.

Total Cost: \$ 1850.00
