Access Compliance Report

Public Rights-of-Way

(Curb Ramps)

Intersection ID: 26115	Main Street: CARMEL_CHACE_DR	Cross Street: CARMEL_RD	Location: SE
ADA ID: 2E5A250ADED2	Ramp Type: PerpDiag	Initial Pass/Fail: Fail	Overall Compliance: No
		Severity Score: 25

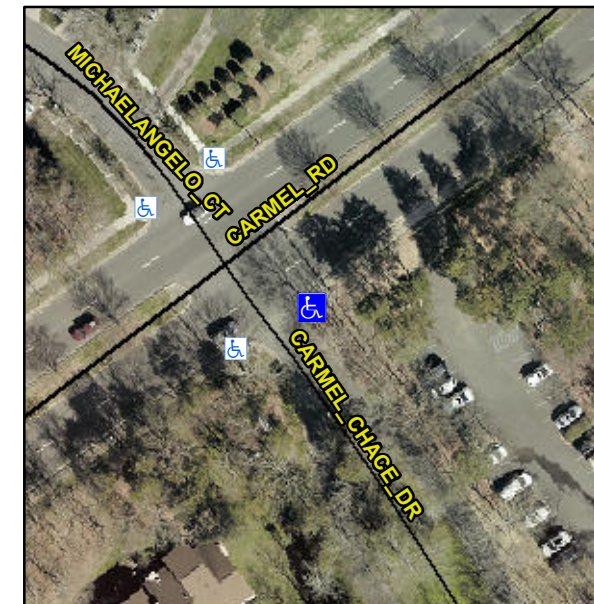
Not Found, R304.5.3

Compliance	Description	Data	Compliance	Description	Data
N/A	Ramp Length (in)	74.0	Yes	Ramp Slope (%)	5.9
Yes	Ramp Width (in)	48.0	No	Ramp XSlope (%)	8.9
N/A	Flare Type LT	N/A	N/A	Flare Type RT	N/A
N/A	Flare Slope LT (%)	N/A	N/A	Flare Slope RT (%)	N/A
N/A	Flare Traversable LT?	N/A	N/A	Flare Traversable RT?	N/A
N/A	Landing Length (in)	N/A	N/A	DWS Provided?	N/A
N/A	Landing Width (in)	N/A	N/A	DWS Contrast?	N/A
N/A	Landing Slope (%)	N/A	N/A	DWS Length (in)	N/A
N/A	Landing X Slope (%)	N/A	N/A	DWS Full Width?	N/A
N/A	Landing Curb? (Y/N)	N/A	N/A	DWS Offset (in)	N/A
N/A	Shared Landing?	N/A			
N/A	Gutter Ponding?	N/A	N/A	Gutter Slope (%)	N/A
N/A	Gutter Lip Ht (in)	N/A	N/A	Gutter X Slope (%)	N/A
N/A	Painted X Walk1?	No	N/A	Painted X Walk2?	No
	X Walk 1 Direction	To N		X Walk 2 Direction	To W
N/A	X Walk 1 Width (in)	N/A	N/A	X Walk 2 Width (in)	N/A
	X Walk 1 Slope (%)	3.8		X Walk 2 Slope (%)	2.4
	X Walk 1 X Slope (%)	2.7		X Walk 2 X Slope (%)	2.9

N/A	Ramp inside XWalk1?	N/A	N/A	Ramp inside XWalk2?	N/A
	Road Slope (%)	2.1	N/A	Clear Space?	N/A
	Road X Slope (%)	1.4	N/A	Clear Space to XWalk (in)	N/A
N/A	Any Obstructions?	N/A	N/A	Storm Grate/Utility Hazard?	N/A
	Obstruction Type			Storm Grate/Utility Type	
		N/A			N/A
		Yes		Surface Condition? (G/P)	Good

Remove & Replace Curb Ramp With Two New Directional Ramps or Equivalent.
