# Access Compliance Report

## Public Rights-of-Way

### (Curb Ramps)

| Intersection ID: 14215 | Main Street: MYRTLE_AV | Cross Street: ROMANY_RD | Location: SW |

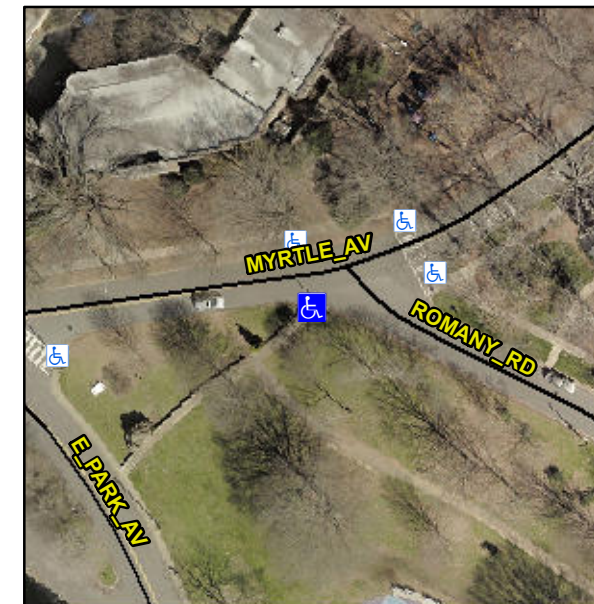
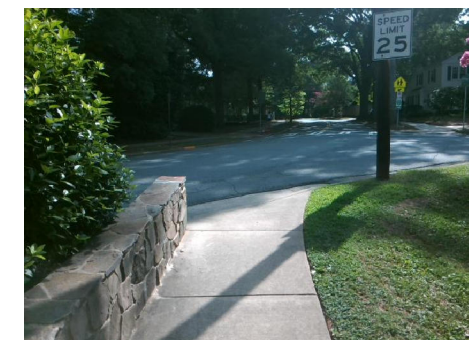
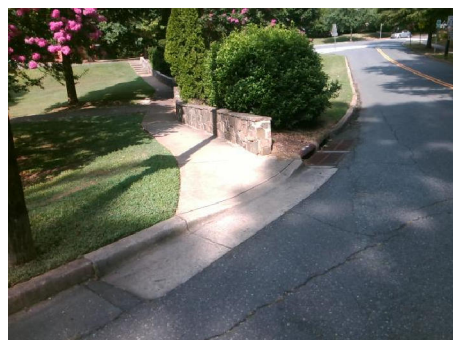
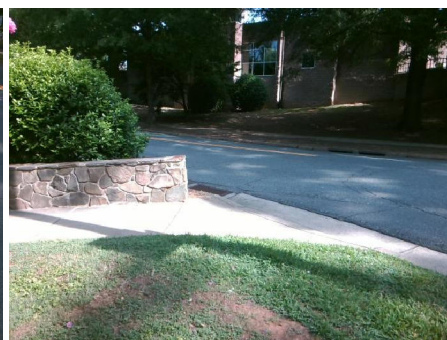
**Not Found, R304.5.3, R304.2.2-Perp, R304.3.2-Para, R305**

| Compliance | Description | Data | Compliance | Description | Data |
|---|---|---|---|---|---|
| Yes | Ramp Width (in) | 48.0 | No | Ramp XSlope (%) | 2.8 |
| Yes | Landing Length (in) | 48.0 | No | DWS Provided? | No |
| No | Landing Slope (%) | 5.5 | N/A | DWS Length (in) | N/A |
| Yes | Gutter Lip Ht (in) | 0.0 | No | Gutter X Slope (%) | 2.3 |

**Remove & Replace Curb Ramp With Two New Directional Ramps or Equivalent. Remove & Replace Gutter.**
