# Access Compliance Report

## Public Rights-of-Way

### (Curb Ramps)

Intersection ID: 32027	Main Street: COLONIAL_REA_CT	Cross Street: STONECROFT_PARK_DR	Location: NE
ADA ID: 2E66AEE5A0AA	Ramp Type: PerpDiag	Initial Pass/Fail: Fail	Overall Compliance: No
Severity Score: 35			
Codes/Mitigation Info/Possible Solution		Field Measurements/Component Compliance

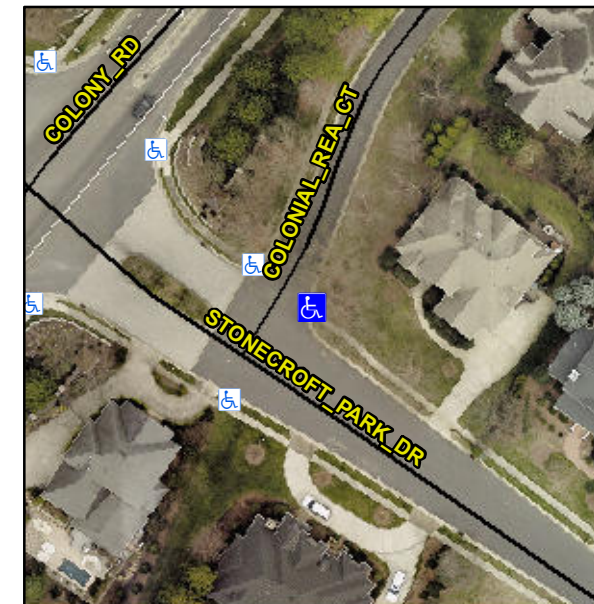
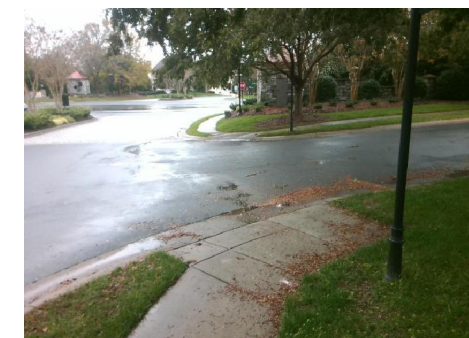
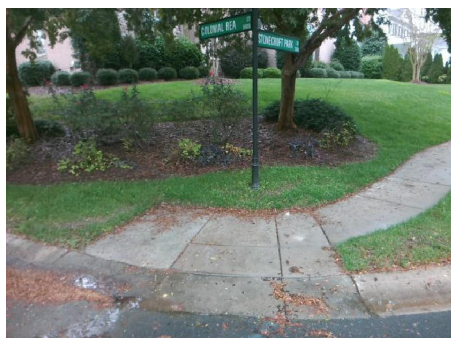
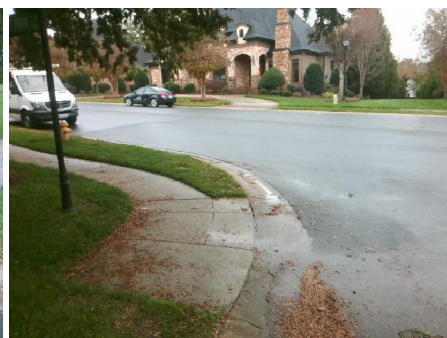
Compliance	Description	Data	Compliance	Description	Data
N/A	Ramp Length (in)	23.0	No	Ramp Slope (%)	12.7
No	Ramp Width (in)	43.0	No	Ramp XSlope (%)	2.5
N/A	Flare Type LT	N/A	N/A	Flare Type RT	N/A
N/A	Flare Slope LT (%)	N/A	N/A	Flare Slope RT (%)	N/A
N/A	Flare Traversable LT?	N/A	N/A	Flare Traversable RT?	N/A
N/A	Landing Length (in)	N/A	N/A	DWS Provided?	N/A
N/A	Landing Width (in)	N/A	N/A	DWS Contrast?	N/A
N/A	Landing Slope (%)	N/A	N/A	DWS Length (in)	N/A
N/A	Landing X Slope (%)	N/A	N/A	DWS Full Width?	N/A
N/A	Landing Curb? (Y/N)	N/A	N/A	DWS Offset (in)	N/A
N/A	Shared Landing?	N/A			
N/A	Gutter Ponding?	N/A	N/A	Gutter Slope (%)	N/A
N/A	Gutter Lip Ht (in)	N/A	N/A	Gutter X Slope (%)	N/A
N/A	Painted X Walk1?	No	N/A	Painted X Walk2?	No
	X Walk 1 Direction	To NW		X Walk 2 Direction	To SW
N/A	X Walk 1 Width (in)	N/A	N/A	X Walk 2 Width (in)	N/A
	X Walk 1 Slope (%)	3.0		X Walk 2 Slope (%)	2.6
	X Walk 1 X Slope (%)	1.5		X Walk 2 X Slope (%)	3.7

N/A	Ramp inside XWalk1?	N/A	N/A	Ramp inside XWalk2?	N/A
	Road Slope (%)	1.1	N/A	Clear Space?	N/A
	Road X Slope (%)	2.0	N/A	Clear Space to XWalk (in)	N/A
N/A	Any Obstructions?	N/A	N/A	Storm Grate/Utility Hazard?	N/A
	Obstruction Type			Storm Grate/Utility Type	
		N/A			N/A
			Yes	Surface Condition? (G/P)	Good

**Remove & Replace Curb Ramp With Two New Directional Ramps or Equivalent.**

**R304.5.1, R304.2.2, R304.5.3**
