Access Compliance Report

Public Rights-of-Way

(Curb Ramps)

Intersection ID: 11786	Main Street: E_17TH_ST	Cross Street: N_MCDOWELL_ST	Location: E
ADA ID: 2E747BEA89E5	Ramp Type: Perp	Initial Pass/Fail: Fail	Overall Compliance: No
		Severity Score: 72.5

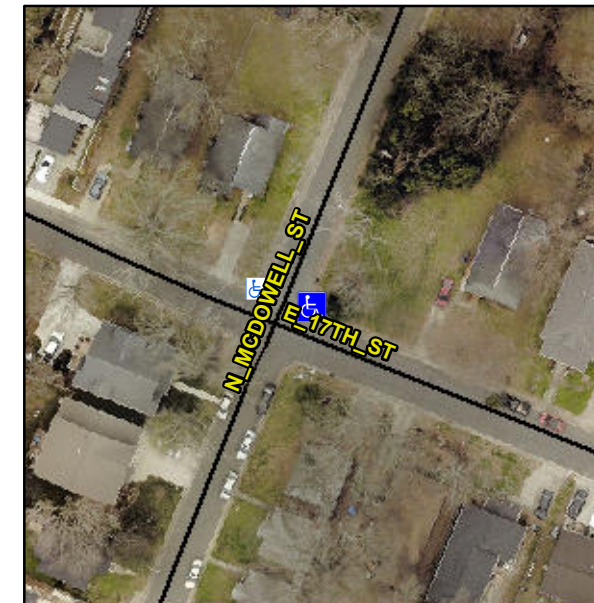
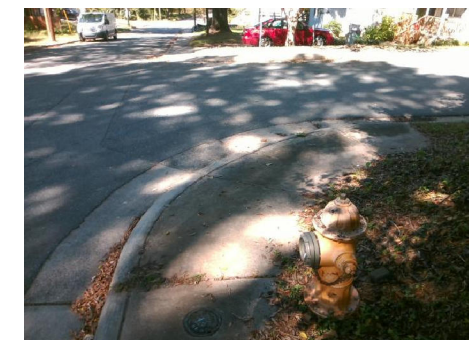
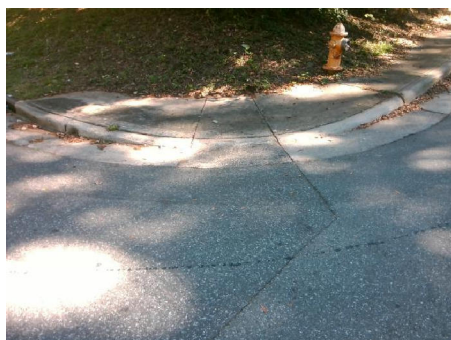
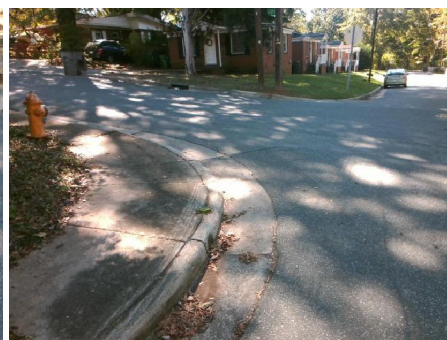
Not Found, R304.5.1, R304.2.2, R304.5.3

Compliance	Description	Data	Compliance	Description	Data
N/A	Ramp Length (in)	64.0	No	Ramp Slope (%)	12.5
No	Ramp Width (in)	28.0	No	Ramp XSlope (%)	5.2
N/A	Flare Type LT	N/A	N/A	Flare Type RT	N/A
N/A	Flare Slope LT (%)	N/A	N/A	Flare Slope RT (%)	N/A
N/A	Flare Traversable LT?	N/A	N/A	Flare Traversable RT?	N/A
N/A	Landing Length (in)	N/A	N/A	DWS Provided?	N/A
N/A	Landing Width (in)	N/A	N/A	DWS Contrast?	N/A
N/A	Landing Slope (%)	N/A	N/A	DWS Length (in)	N/A
N/A	Landing X Slope (%)	N/A	N/A	DWS Full Width?	N/A
N/A	Landing Curb? (Y/N)	N/A	N/A	DWS Offset (in)	N/A
N/A	Shared Landing?	N/A			
N/A	Gutter Ponding?	N/A	N/A	Gutter Slope (%)	N/A
N/A	Gutter Lip Ht (in)	N/A	N/A	Gutter X Slope (%)	N/A
N/A	Painted X Walk1?	No	N/A	Painted X Walk2?	N/A
	X Walk 1 Direction	To NW		X Walk 2 Direction	N/A
N/A	X Walk 1 Width (in)	N/A	N/A	X Walk 2 Width (in)	N/A
	X Walk 1 Slope (%)	2.3		X Walk 2 Slope (%)	N/A
	X Walk 1 X Slope (%)	1.9		X Walk 2 X Slope (%)	N/A

N/A	Ramp inside XWalk1?	N/A	N/A	Ramp inside XWalk2?	N/A
	Road Slope (%)	N/A	N/A	Clear Space?	N/A
	Road X Slope (%)	N/A	N/A	Clear Space to XWalk (in)	N/A
N/A	Any Obstructions?	N/A	N/A	Storm Grate/Utility Hazard?	N/A
	Obstruction Type			Storm Grate/Utility Type	
		N/A			N/A
			Yes	Surface Condition? (G/P)	Good

Remove & Replace Entire Ramp.
