Access Compliance Report Public Rights-of-Way (Curb Ramps)

Intersection ID: 16830 Main Street: MALVERN RD **Cross Street: SHARON RD** Location: NE ADA ID: 2E75C369A212 Ramp Type: PerpDiag Initial Pass/Fail: Fail **Overall Compliance: No Severity Score:** 12.5

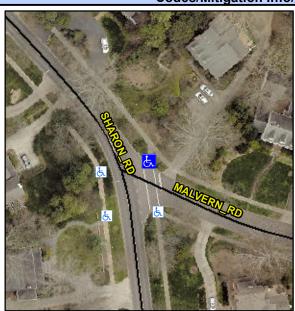
r iola incacaromento/component compilarios						
Compliance Description		Data	Compliance Description		Data	
N/A	Ramp Length (in)	50.0	No	Ramp Slope (%)	8.8	
Yes	Ramp Width (in)	48.0	Yes	Ramp XSlope (%)	1.1	
N/A	Flare Type LT	N/A	N/A	Flare Type RT	N/A	
N/A	Flare Slope LT (%)	N/A	N/A	Flare Slope RT (%)	N/A	
N/A	Flare Traversable LT?	N/A	N/A	Flare Traversable RT?	N/A	
N/A	Landing Length (in)	N/A	N/A	DWS Provided?	N/A	
N/A	Landing Width (in)	N/A	N/A	DWS Contrast?	N/A	
N/A	Landing Slope (%)	N/A	N/A	DWS Length (in)	N/A	
N/A	Landing X Slope (%)	N/A	N/A	DWS Full Width?	N/A	
N/A	Landing Curb? (Y/N)	N/A	N/A	DWS Offset (in)	N/A	
N/A	Shared Landing?	N/A				
N/A	Gutter Ponding?	N/A	N/A	Gutter Slope (%)	N/A	
N/A	Gutter Lip Ht (in)	N/A	N/A	Gutter X Slope (%)	N/A	
N/A	Painted X Walk1?	No	N/A	Painted X Walk2?	Yes	
	X Walk 1 Direction	To W		X Walk 2 Direction	To SW	
N/A	X Walk 1 Width (in)	N/A	N/A	X Walk 2 Width (in)	115.0

X Walk 1 Slope (%)	7.3		X Walk 2 Slope (%)	1.5	
	X Walk 1 X Slope (%)	1.3		X Walk 2 X Slope (%)	6.1	
N/A	Ramp inside XWalk1?	N/A	N/A	Ramp inside XWalk2?	Yes	
	Road Slope (%)	3.2	N/A	Clear Space?	N/A	
	Road X Slope (%)	4.8	N/A	Clear Space to XWalk (in)	N/A	
N/A	Any Obstructions?	N/A	N/A	Storm Grate/Utility Hazard?	N/A

SHARON RD None **MALVERN RD** StopSign Possible Solutions: Remove & Replace Curb Ramp With **Two New Directional Ramps or** Equivalent. Surveyor Notes: N/A PROW/ADA: R304.2.2
