# Access Compliance Report

## Public Rights-of-Way

### (Curb Ramps)

Intersection ID: 10037286	Main Street: SARDIS_RD_NORTH	Cross Street: N/A	Location: N
ADA ID: 2E7CBC4E3D8E	Ramp Type: Para	Initial Pass/Fail: Fail	Overall Compliance: No
Codes/Mitigation Info/Possible Solution		Field Measurements/Component Compliance

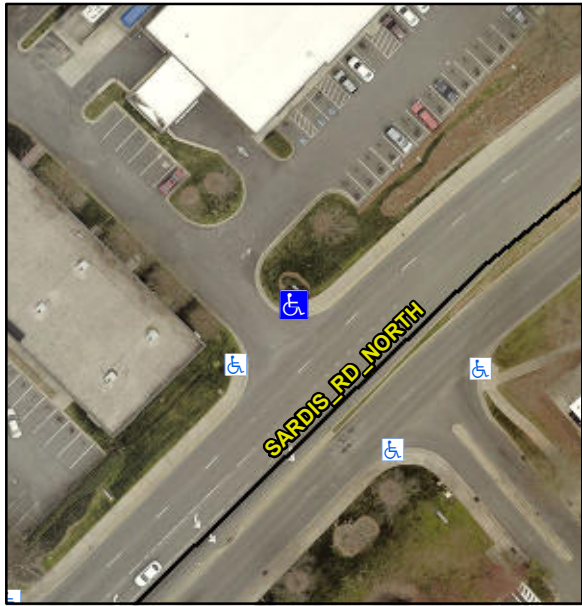
LT RP < 5%

R304.5.3, R304.3.2

Compliance	Description	Data	Compliance	Description	Data
N/A	Ramp Length LT (in)	58.0	N/A	Ramp Length RT (in)	63.0
Yes	Ramp Width LT (in)	72.0	Yes	Ramp Width RT (in)	67.0
Yes	Ramp Slope LT (%)	3.1	No	Ramp Slope RT (%)	11.1
No	Ramp XSlope LT (%)	3.1	Yes	Ramp XSlope RT (%)	1.0
N/A	Landing Length (in)	N/A	N/A	DWS Provided?	N/A
N/A	Landing Width (in)	N/A	N/A	DWS Contrast?	N/A
N/A	Landing Slope (%)	N/A	N/A	DWS Length (in)	N/A
N/A	Landing X Slope (%)	N/A	N/A	DWS Full Width?	N/A
N/A	Landing Curb? (Y/N)	N/A	N/A	DWS Offset (in)	N/A
N/A	Shared Landing?	N/A			
N/A	Gutter Ponding?	N/A	N/A	Gutter Slope (%)	N/A
N/A	Gutter Lip Ht (in)	N/A	N/A	Gutter X Slope (%)	N/A
N/A	Painted X Walk1?	No	N/A	Painted X Walk2?	N/A
	X Walk 1 Direction	To SW		X Walk 2 Direction	N/A
N/A	X Walk 1 Width (in)	N/A	N/A	X Walk 2 Width (in)	N/A
	X Walk 1 Slope (%)	3.5		X Walk 2 Slope (%)	N/A
	X Walk 1 X Slope (%)	3.9		X Walk 2 X Slope (%)	N/A
N/A	Ramp inside XWalk1?	N/A	N/A	Ramp inside XWalk2?	N/A

Road Slope (%)	N/A	N/A	Clear Space?	N/A
	Road X Slope (%)	N/A	N/A	Clear Space to XWalk (in)	N/A
N/A	Any Obstructions?	N/A	N/A	Storm Grate/Utility Hazard?	N/A
	Obstruction Type			Storm Grate/Utility Type	
		N/A			N/A
			Yes	Surface Condition? (G/P)	Good
			N/A	Curb Slope (%)	3.6

Remove & Replace Entire Ramp.

1600.00
