## Access Compliance Report Public Rights-of-Way (Curb Ramps)

Intersection ID: 12054 Main Street: MCNINCH\_ST Cross Street: W\_HILL\_ST Location: E

ADA ID: 2E86D1C1CF30 Ramp Type: Perp Initial Pass/Fail: Pass Overall Compliance: No Severity Score: 0

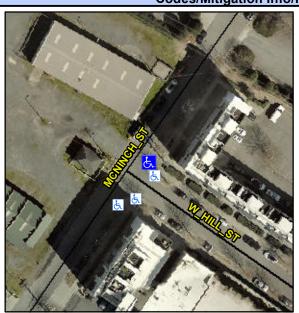
Field Measurements/Component Compliance					
Compliance Description		Data	Compliance Description		Data
N/A	Ramp Length (in)	72.0	Yes	Ramp Slope (%)	7.3
Yes	Ramp Width (in)	48.0	Yes	Ramp XSlope (%)	1.5
N/A	Flare Type LT	Sloped	N/A	Flare Type RT	N/A
N/A	Flare Slope LT (%)	5.7	Yes	Flare Slope RT (%)	6.4
N/A	Flare Traversable LT?	Yes	N/A	Flare Traversable RT?	Yes
Yes	Landing Length (in)	72.0	Yes	DWS Provided?	Yes
Yes	Landing Width (in)	48.0	Yes	DWS Contrast?	Yes
No	Landing Slope (%)	2.4	Yes	DWS Length (in)	24.0
Yes	Landing X Slope (%)	0.0	Yes	DWS Full Width?	Yes
N/A	Landing Curb? (Y/N)	No	No	DWS Offset (in)	3.0
N/A	Shared Landing?	Yes			
Yes	Gutter Ponding?	No	Yes	Gutter Slope (%)	1.1
Yes	Gutter Lip Ht (in)	0.0	Yes	Gutter X Slope (%)	0.9
N/A	Painted X Walk1?	No	N/A	Painted X Walk2?	N/A
	X Walk 1 Direction	To NW		X Walk 2 Direction	N/A
N/A	X Walk 1 Width (in)	N/A	N/A	X Walk 2 Width (in)	N/A
	X Walk 1 Slope (%)	3.4		X Walk 2 Slope (%)	N/A

X Walk 1 X Slope (%)	0.8		X Walk 2 X Slope (%)	N/A
N/A	Ramp inside XWalk1?	N/A	N/A	Ramp inside XWalk2?	N/A
	Road Slope (%)	N/A	N/A	Clear Space?	Yes
	Road X Slope (%)	N/A	N/A	Clear Space to XWalk (in)	N/A
Yes	Any Obstructions?	No	Yes	Storm Grate/Utility Hazard?	Yes
	Obstruction Type		l	Storm Grate/Utility Type	
		N/A			МН
			Yes	Surface Condition? (G/P)	Good

Possible Solutions:

Remove & Replace Entire Ramp.
Utility Present.
