## **Access Compliance Report Public Rights-of-Way** (Curb Ramps)

Intersection ID: 10690 Main Street: CHARLES\_AV Cross Street: WHITING\_AV Location: NW **Overall Compliance: No** ADA ID: 2E876D7E747A Ramp Type: Perp Initial Pass/Fail: Fail **Severity Score:** 1.25

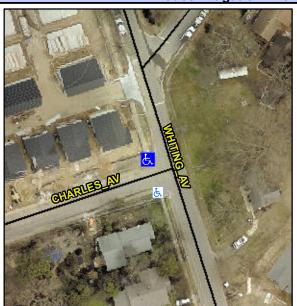
Field Measurements/Component Compliance							
Comp	Compliance Description		Comp	liance Description	Data		
N/A	Ramp Length (in)	26.0	Yes	Ramp Slope (%)	6.5		
Yes	Ramp Width (in)	48.0	No	Ramp XSlope (%)	2.3		
N/A	Flare Type LT	N/A	N/A	Flare Type RT	N/A		
N/A	Flare Slope LT (%)	N/A	N/A	Flare Slope RT (%)	N/A		
N/A	Flare Traversable LT?	N/A	N/A	Flare Traversable RT?	N/A		
N/A	Landing Length (in)	N/A	N/A	DWS Provided?	N/A		
N/A	Landing Width (in)	N/A	N/A	DWS Contrast?	N/A		
N/A	Landing Slope (%)	N/A	N/A	DWS Length (in)	N/A		
N/A	Landing X Slope (%)	N/A	N/A	DWS Full Width?	N/A		
N/A	Landing Curb? (Y/N)	N/A	N/A	DWS Offset (in)	N/A		
N/A	Shared Landing?	N/A					
N/A	Gutter Ponding?	N/A	N/A	Gutter Slope (%)	N/A		
N/A	Gutter Lip Ht (in)	N/A	N/A	Gutter X Slope (%)	N/A		
N/A	Painted X Walk1?	No	N/A	Painted X Walk2?	N/A		
	X Walk 1 Direction	To S		X Walk 2 Direction	N/A		
N/A	X Walk 1 Width (in)	N/A	N/A	X Walk 2 Width (in)	N/A

X Walk 1 Slope (%)	3.5		X Walk 2 Slope (%)	N/A		
	X Walk 1 X Slope (%)	1.0		X Walk 2 X Slope (%)	N/A		
N/A	Ramp inside XWalk1?	N/A	N/A	Ramp inside XWalk2?	N/A		
	Road Slope (%)	N/A	N/A	Clear Space?	N/A		
	Road X Slope (%)	N/A	N/A	Clear Space to XWalk (in)	N/A		
N/A	Any Obstructions?	N/A	N/A	Storm Grate/Utility Hazard?	N/A		
	Obstruction Type			Storm Grate/Utility Type			
		N/A			N/A		
			Yes	Surface Condition? (G/P)	Good		
1	Way.

Possible Solutions:	<u>c</u>		
Remove & Replace Entire Ramp.			
	Y		
	N.		
	N		
	N		
	N		
Surveyor Notes:	N		
N/A	N		
	N		
	N		
	N		
PROW/ADA:	N		
Not Found, R304.5.3	N.		
	N		
	N
