Access Compliance Report

Public Rights-of-Way

(Curb Ramps)

Intersection ID: 7952	Main Street: JULIA_AV	Cross Street: CARMINE_ST	Location: NW
ADA ID: 2E8FECA2BA78	Ramp Type: Perp	Initial Pass/Fail: Fail	Overall Compliance: No
Codes/Mitigation Info/Possible Solution		Field Measurements/Component Compliance	
Severity Score: 13.75

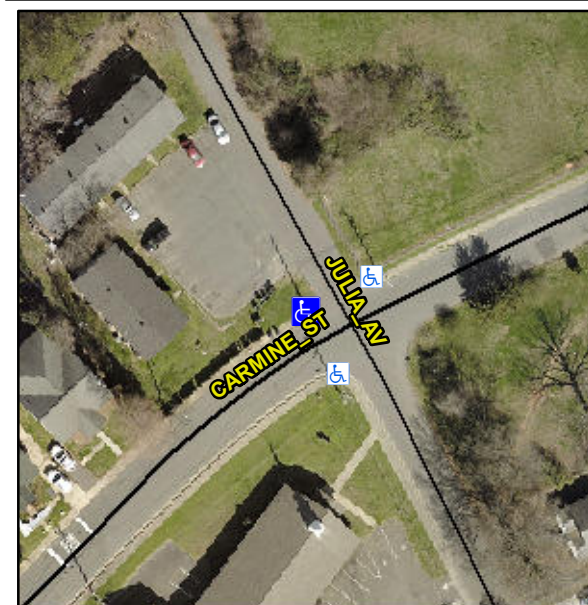
Not Found, R304.2.2

Compliance	Description	Data	Compliance	Description	Data
N/A	Ramp Length (in)	35.0	No	Ramp Slope (%)	11.7
Yes	Ramp Width (in)	48.0	Yes	Ramp XSlope (%)	2.5
N/A	Flare Type LT	N/A	N/A	Flare Type RT	N/A
N/A	Flare Slope LT (%)	N/A	N/A	Flare Slope RT (%)	N/A
N/A	Flare Traversable LT?	N/A	N/A	Flare Traversable RT?	N/A
N/A	Landing Length (in)	N/A	N/A	DWS Provided?	N/A
N/A	Landing Width (in)	N/A	N/A	DWS Contrast?	N/A
N/A	Landing Slope (%)	N/A	N/A	DWS Length (in)	N/A
N/A	Landing X Slope (%)	N/A	N/A	DWS Full Width?	N/A
N/A	Landing Curb? (Y/N)	N/A	N/A	DWS Offset (in)	N/A
N/A	Shared Landing?	N/A			
N/A	Gutter Ponding?	N/A	N/A	Gutter Slope (%)	N/A
N/A	Gutter Lip Ht (in)	N/A	N/A	Gutter X Slope (%)	N/A
N/A	Painted X Walk1?	No	N/A	Painted X Walk2?	N/A
	X Walk 1 Direction	To S		X Walk 2 Direction	N/A
N/A	X Walk 1 Width (in)	N/A	N/A	X Walk 2 Width (in)	N/A
	X Walk 1 Slope (%)	2.0		X Walk 2 Slope (%)	N/A
	X Walk 1 X Slope (%)	2.6		X Walk 2 X Slope (%)	N/A

N/A	Ramp inside XWalk1?	N/A	N/A	Ramp inside XWalk2?	N/A
	Road Slope (%)	N/A	N/A	Clear Space?	N/A
	Road X Slope (%)	N/A	N/A	Clear Space to XWalk (in)	N/A
N/A	Any Obstructions?	N/A	N/A	Storm Grate/Utility Hazard?	N/A
	Obstruction Type			Storm Grate/Utility Type	
		N/A			N/A
			Yes	Surface Condition? (G/P)	Good

Possible Solutions:

Remove & Replace Entire Ramp.
