Access Compliance Report

Public Rights-of-Way

(Curb Ramps)

Intersection ID: 28279	Main Street: COMMUNITY_HOUSE_RD	Cross Street: PURCHASE_ST	Location: N
ADA ID: 2E91C972807E	Ramp Type: Directional1	Initial Pass/Fail: Fail	Overall Compliance: No
Severity Score: 12.5			
Codes/Mitigation Info/Possible Solution		Field Measurements/Component Compliance

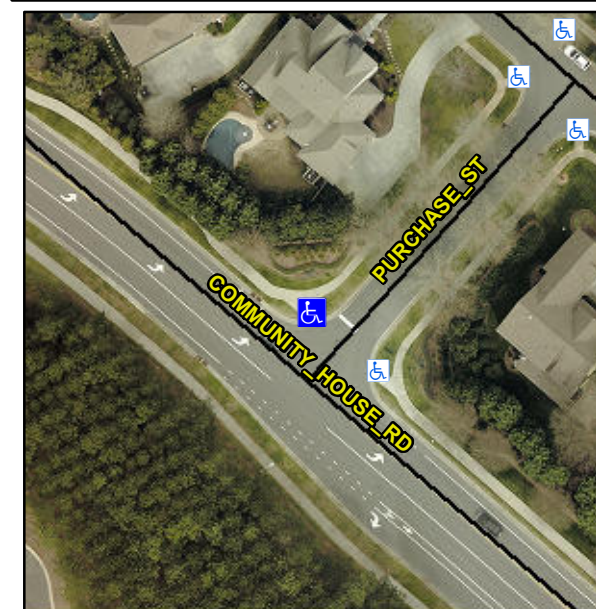
R304.2.2

Compliance	Description	Data	Compliance	Description	Data
N/A	Ramp Length (in)	150.0	N/A	Grade Break?	N/A
Yes	Ramp Width (in)	70.0	N/A	Grade Break Slope (%)	0.0
No	Ramp Slope (%)	9.7	N/A	Grade Break XSlope (%)	0.0
Yes	Ramp XSlope (%)	0.8			
N/A	Flare Type LT	N/A	N/A	Flare Type RT	N/A
N/A	Flare Slope LT (%)	N/A	N/A	Flare Slope RT (%)	0.0
N/A	Flare Traversable LT?	N/A	N/A	Flare Traversable RT?	N/A
N/A	Landing Length (in)	0.0	N/A	DWS Provided?	N/A
N/A	Landing Width (in)	0.0	N/A	DWS Contrast?	N/A
N/A	Landing Slope (%)	0.0	N/A	DWS Length (in)	N/A
N/A	Landing X Slope (%)	0.0	N/A	DWS Full Width?	N/A
N/A	Landing Curb? (Y/N)	N/A	N/A	DWS Offset LT (in)	N/A
N/A	Shared Landing?	N/A	N/A	DWS Offset RT (in)	N/A
N/A	Gutter Ponding?	0.0	N/A	Gutter Slope (%)	N/A
N/A	Gutter Lip Ht (in)	0.0	N/A	Gutter X Slope (%)	N/A
N/A	Painted X Walk1?	No		Road Slope (%)	1.2
	X Walk 1 Direction	To SE		Road X Slope (%)	4.4
	X Walk 1 Width (in)	N/A		Clear Space?	N/A

X Walk 1 Slope (%)	1.2	N/A	Clear Space to XWalk (in)	N/A
	X Walk 1 X Slope (%)	4.4	N/A	Storm Grate/Utility Hazard?	N/A
N/A	Ramp inside XWalk1?	N/A		Storm Grate/Utility Type	
N/A	Any Obstructions?	N/A			N/A
	Obstruction Type		Yes	Surface Condition? (G/P)	Good
			N/A	Curb Slope (%)	7.9

Possible Solutions:

Remove & Replace Entire Ramp.
