Access Compliance Report

Public Rights-of-Way

(Curb Ramps)

Intersection ID: N/A	Main Street: E 8TH ST	Cross Street: N BREVARD ST	Location: N
ADA ID: 2E9BB8D6C5B5	Ramp Type: Perp	Initial Pass/Fail: Fail	Overall Compliance: No
Severity Score: 21.25			
Codes/Mitigation Info/Possible Solution		Field Measurements/Component Compliance

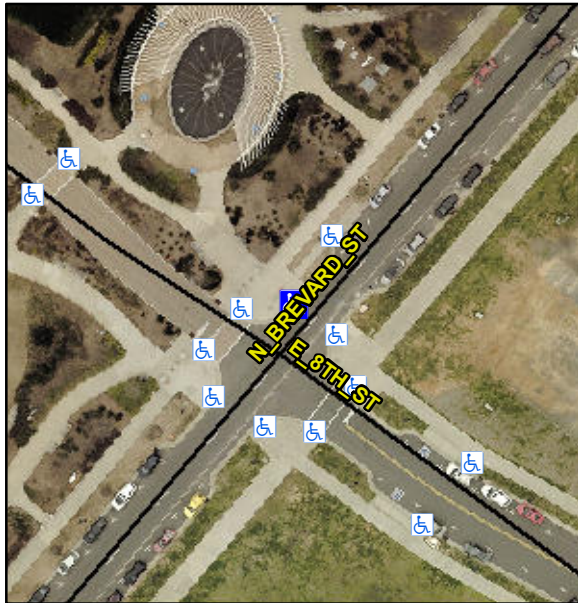
Compliance	Description	Data	Compliance	Description	Data
N/A	Ramp Length (in)	71.0	No	Ramp Slope (%)	9.6
No	Ramp Width (in)	39.0	Yes	Ramp XSlope (%)	0.3
N/A	Flare Type LT	N/A	N/A	Flare Type RT	N/A
N/A	Flare Slope LT (%)	N/A	N/A	Flare Slope RT (%)	N/A
N/A	Flare Traversable LT?	No	N/A	Flare Traversable RT?	No
N/A	Landing Length (in)	N/A	N/A	DWS Provided?	N/A
N/A	Landing Width (in)	N/A	N/A	DWS Contrast?	N/A
N/A	Landing Slope (%)	N/A	N/A	DWS Length (in)	N/A
N/A	Landing X Slope (%)	N/A	N/A	DWS Full Width?	N/A
N/A	Landing Curb? (Y/N)	N/A	N/A	DWS Offset (in)	N/A
N/A	Shared Landing?	N/A			
N/A	Gutter Ponding?	N/A	N/A	Gutter Slope (%)	N/A
N/A	Gutter Lip Ht (in)	N/A	N/A	Gutter X Slope (%)	N/A
N/A	Painted X Walk1?	No	N/A	Painted X Walk2?	N/A
	X Walk 1 Direction	To SE		X Walk 2 Direction	N/A
N/A	X Walk 1 Width (in)	N/A	N/A	X Walk 2 Width (in)	N/A
	X Walk 1 Slope (%)	1.5		X Walk 2 Slope (%)	N/A
	X Walk 1 X Slope (%)	0.6		X Walk 2 X Slope (%)	N/A

N/A	Ramp inside XWalk1?	N/A	N/A	Ramp inside XWalk2?	N/A
	Road Slope (%)	N/A	N/A	Clear Space?	N/A
	Road X Slope (%)	N/A	N/A	Clear Space to XWalk (in)	N/A
N/A	Any Obstructions?	N/A	N/A	Storm Grate/Utility Hazard?	N/A
	Obstruction Type			Storm Grate/Utility Type	
		N/A			N/A
			Yes	Surface Condition? (G/P)	Good

Possible Solutions:

Remove & Replace Entire Ramp.

R304.5.1, R304.2.2
