Access Compliance Report

Public Rights-of-Way

(Curb Ramps)

Intersection ID: 24896	Main Street: GADWALL_CT	Cross Street: KING_EIDER_DR	Location: SE
ADA ID: 2EA5D48D51AA	Ramp Type: Directional1	Initial Pass/Fail: Fail	Overall Compliance: No
Severity Score: 1.25			
Codes/Mitigation Info/Possible Solution		Field Measurements/Component Compliance

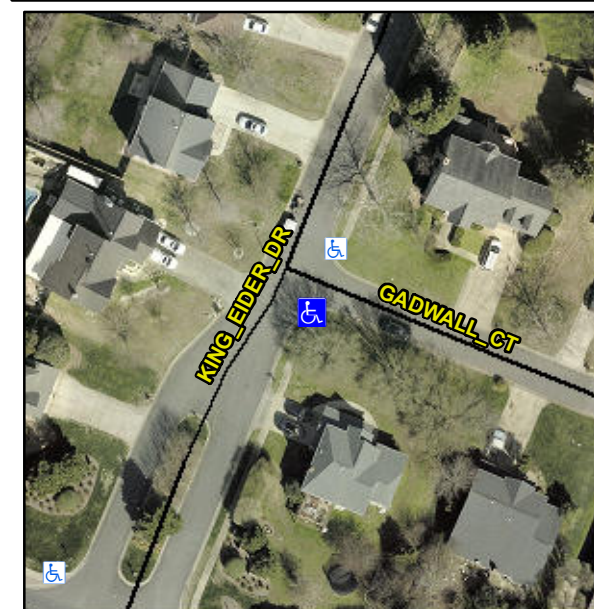
Compliance	Description	Data	Compliance	Description	Data
N/A	Ramp Length (in)	30.0	N/A	Grade Break?	N/A
Yes	Ramp Width (in)	48.0	N/A	Grade Break Slope (%)	0.0
Yes	Ramp Slope (%)	7.6	N/A	Grade Break XSlope (%)	0.0
No	Ramp XSlope (%)	3.6			
N/A	Flare Type LT	N/A	N/A	Flare Type RT	N/A
N/A	Flare Slope LT (%)	N/A	N/A	Flare Slope RT (%)	0.0
N/A	Flare Traversable LT?	N/A	N/A	Flare Traversable RT?	N/A
N/A	Landing Length (in)	0.0	N/A	DWS Provided?	N/A
N/A	Landing Width (in)	0.0	N/A	DWS Contrast?	N/A
N/A	Landing Slope (%)	0.0	N/A	DWS Length (in)	N/A
N/A	Landing X Slope (%)	0.0	N/A	DWS Full Width?	N/A
N/A	Landing Curb? (Y/N)	N/A	N/A	DWS Offset LT (in)	N/A
N/A	Shared Landing?	N/A	N/A	DWS Offset RT (in)	N/A
N/A	Gutter Ponding?	0.0	N/A	Gutter Slope (%)	N/A
N/A	Gutter Lip Ht (in)	0.0	N/A	Gutter X Slope (%)	N/A
N/A	Painted X Walk1?	No		Road Slope (%)	2.8
	X Walk 1 Direction	To N		Road X Slope (%)	3.7
	X Walk 1 Width (in)	N/A		Clear Space?	N/A

X Walk 1 Slope (%)	2.8	N/A	Clear Space to XWalk (in)	N/A
	X Walk 1 X Slope (%)	3.7	N/A	Storm Grate/Utility Hazard?	N/A
N/A	Ramp inside XWalk1?	N/A		Storm Grate/Utility Type	
N/A	Any Obstructions?	N/A			N/A
	Obstruction Type		Yes	Surface Condition? (G/P)	Good
			N/A	Curb Slope (%)	33.5

Possible Solutions:

Remove & Replace Entire Ramp.

R304.5.3
