# Access Compliance Report

## Public Rights-of-Way

### (Curb Ramps)

Intersection ID: 44770	Main Street: KINGS_PARADE_BV	Cross Street: OBAN_PASSAGE_DR	Location: NE
ADA ID: 2ED42B2332A6	Ramp Type: PerpDiag	Initial Pass/Fail: Fail	Overall Compliance: No
Severity Score: 10			
Codes/Mitigation Info/Possible Solution		Field Measurements/Component Compliance

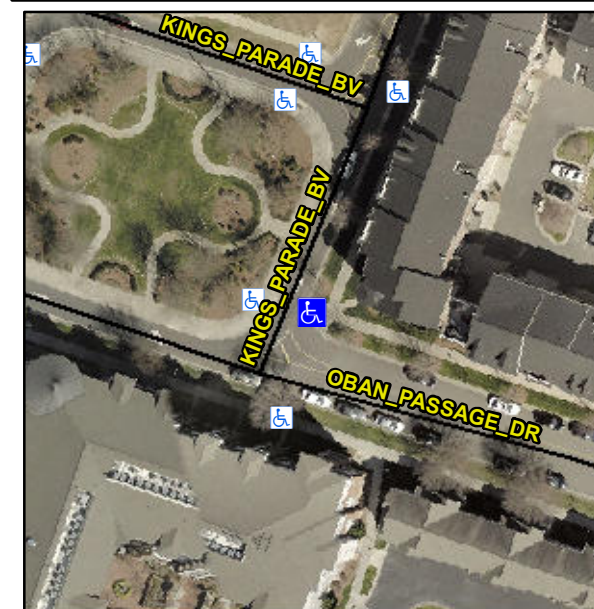
Compliance	Description	Data	Compliance	Description	Data
N/A	Ramp Length (in)	97.5	Yes	Ramp Slope (%)	6.1
No	Ramp Width (in)	47.0	No	Ramp XSlope (%)	4.9
N/A	Flare Type LT	N/A	N/A	Flare Type RT	N/A
N/A	Flare Slope LT (%)	N/A	N/A	Flare Slope RT (%)	N/A
N/A	Flare Traversable LT?	N/A	N/A	Flare Traversable RT?	N/A
N/A	Landing Length (in)	N/A	N/A	DWS Provided?	N/A
N/A	Landing Width (in)	N/A	N/A	DWS Contrast?	N/A
N/A	Landing Slope (%)	N/A	N/A	DWS Length (in)	N/A
N/A	Landing X Slope (%)	N/A	N/A	DWS Full Width?	N/A
N/A	Landing Curb? (Y/N)	N/A	N/A	DWS Offset (in)	N/A
N/A	Shared Landing?	N/A			
N/A	Gutter Ponding?	N/A	N/A	Gutter Slope (%)	N/A
N/A	Gutter Lip Ht (in)	N/A	N/A	Gutter X Slope (%)	N/A
N/A	Painted X Walk1?	No	N/A	Painted X Walk2?	No
	X Walk 1 Direction	To W		X Walk 2 Direction	To S
N/A	X Walk 1 Width (in)	N/A	N/A	X Walk 2 Width (in)	N/A
	X Walk 1 Slope (%)	6.1		X Walk 2 Slope (%)	1.4
	X Walk 1 X Slope (%)	2.7		X Walk 2 X Slope (%)	4.0

N/A	Ramp inside XWalk1?	N/A	N/A	Ramp inside XWalk2?	N/A
	Road Slope (%)	3.5	N/A	Clear Space?	N/A
	Road X Slope (%)	3.6	N/A	Clear Space to XWalk (in)	N/A
N/A	Any Obstructions?	N/A	N/A	Storm Grate/Utility Hazard?	N/A
	Obstruction Type			Storm Grate/Utility Type	
		N/A			N/A
		Yes		Surface Condition? (G/P)	Good

Possible Solutions:

**Remove & Replace Curb Ramp With Two New Directional Ramps or Equivalent.**

PROW/ADA:

**R304.5.1, R304.5.3**
