Access Compliance Report Public Rights-of-Way (Curb Ramps)

/
Intersection ID: 8774	Main Str	Main Street: FREEDOM_DR			et: R	ANCH_RD	Location:	Е		
ADA ID: 2ED6D54AA813	Ramp Type: Perp			Initial Pass/Fail: Fail Overall Compliance: No				o Severity Score:	10	
Codes/Mitigation Info/Possible Solution			Field Measurements/Component Compliance							
		Possible Solutions:		Compliance Description Data Comp					liance Description	Data
	A State	Remove & Replace E	ntire Ramp.	N//	A R	Ramp Length (in)	84.5	Yes	Ramp Slope (%)	6.1
	AUTOR			No	R	Ramp Width (in)	47.0	No	Ramp XSlope (%)	3.1
				N//	A F	Flare Type LT	N/A	N/A	Flare Type RT	N/A
	~ /			N//	4 F	Flare Slope LT (%)	N/A	N/A	Flare Slope RT (%)	N/A
8	- 100			N//		Flare Traversable LT?	N/A	N/A	Flare Traversable RT?	N/A
8	Jan NY			N//	A L	anding Length (in)	N/A	N/A	DWS Provided?	N/A
ti ti		Surveyor Notes:		N//	A L	anding Width (in)	N/A	N/A	DWS Contrast?	N/A
		N/A		N//		anding Slope (%)	N/A	N/A	DWS Length (in)	N/A

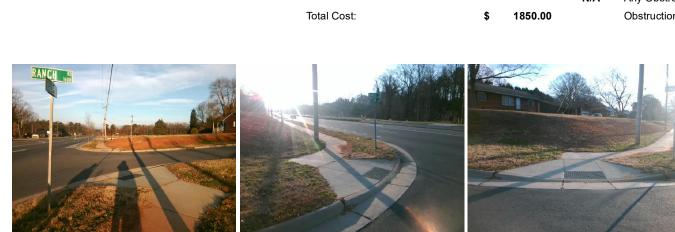
-	PROW/ADA:		N//	A G	Gutter Ponding?	N/A	N/A	Gutter Slope (%)	N/A
and the second s	- 10	Not Found, R304.5.1	R304 5 3	N//		Gutter Lip Ht (in)	N/A	N/A	Gutter X Slope (%)	N/A
A State Mark	and the second s		, 1004.0.0	N//		Painted X Walk1?	No		Painted X Walk2?	N/A
		1				Walk 1 Direction	To NW		X Walk 2 Direction	N/A
				N//	۹ x	(Walk 1 Width (in)	N/A	N/A	X Walk 2 Width (in)	N/A
Street 1 Name	RANCH RD	-				(Walk 1 Slope (%)	1.3		X Walk 2 Slope (%)	N/A
Stop Condition-Street 2	StopSign					(Walk 1 X Slope (%)	3.3		X Walk 2 X Slope (%)	N/A
Street 2 Name	N/A			N/A		Ramp inside XWalk1?	N/A	N/A	Ramp inside XWalk2?	N/A
Stop Condition-Street 1	N/A					Road Slope (%)	N/A	N/A	Clear Space?	N/A
						Road X Slope (%)	N/A	N/A	Clear Space to XWalk (in)	N/A
				N//		Any Obstructions?	N/A		Storm Grate/Utility Hazard?	N/A
		Total Cost:	\$ 1	850.00		Dbstruction Type			Storm Grate/Utility Type
