Access Compliance Report

Public Rights-of-Way

(Curb Ramps)

| Intersection ID: 10888 | Main Street: DRUMMOND_AV | Cross Street: PINCKNEY_AV | Location: | E |

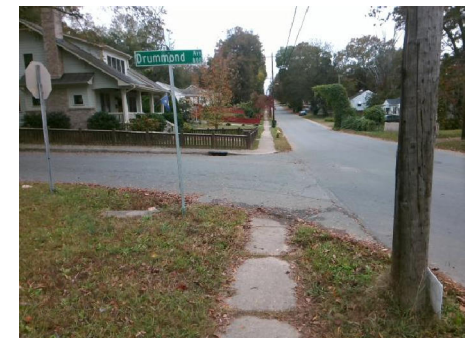
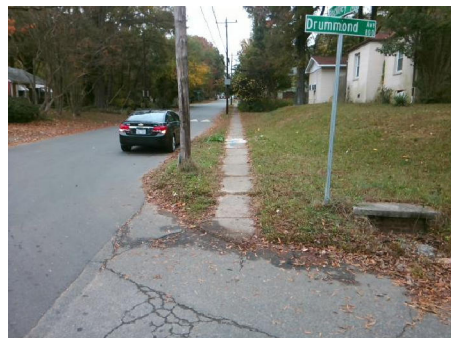
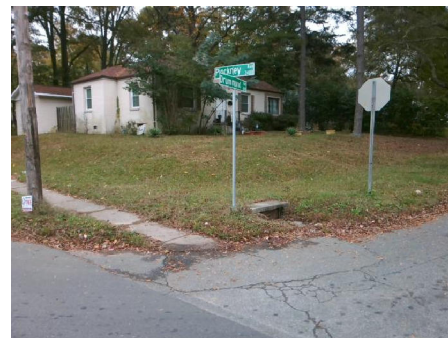
| ADA ID: 2EE4EFFEDA45 | Ramp Type: BlendTrans1 | Initial Pass/Fail: Fail | Overall Compliance: No | Severity Score: 1.25 |

R304.5.3

| Compliance | Description | Data | Compliance | Description | Data |
|---|---|---|---|---|---|
| Yes | Ramp Width (in) | 48.0 | No | BlendTrans XSlope (%) | 2.5 |

Remove & Replace Curb Ramp With Two New Directional Ramps or Equivalent.
