## **Access Compliance Report Public Rights-of-Way** (Curb Ramps)

Intersection ID: 16159 Main Street: HOLLIS RD **Cross Street: SLOAN\_ST** Location: N **Overall Compliance: No** ADA ID: 2EECD8E0C414 Ramp Type: Perp Initial Pass/Fail: Pass **Severity Score:** 0.25

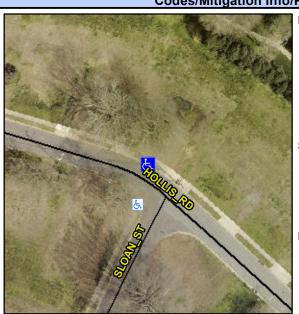
Field Measurements/Component Compliance						
Comp	liance Description	Data	Comp	liance Description	Data	
N/A	Ramp Length (in)	60.0	Yes	Ramp Slope (%)	6.1	
Yes	Ramp Width (in)	48.0	No	Ramp XSlope (%)	4.9	
N/A	Flare Type LT	Sloped	N/A	Flare Type RT	N/A	
N/A	Flare Slope LT (%)	6.2	Yes	Flare Slope RT (%)	0.2	
N/A	Flare Traversable LT?	Yes	N/A	Flare Traversable RT?	Yes	
Yes	Landing Length (in)	52.0	Yes	DWS Provided?	Yes	
No	Landing Width (in)	47.5	Yes	DWS Contrast?	Yes	
No	Landing Slope (%)	2.1	Yes	DWS Length (in)	25.0	
Yes	Landing X Slope (%)	2.6	Yes	DWS Full Width?	Yes	
N/A	Landing Curb? (Y/N)	No	Yes	DWS Offset (in)	0.0	
N/A	Shared Landing?	No				
Yes	Gutter Ponding?	No	Yes	Gutter Slope (%)	2.7	
Yes	Gutter Lip Ht (in)	0.0	No	Gutter X Slope (%)	4.3	
N/A	Painted X Walk1?	No	N/A	Painted X Walk2?	N/A	
	X Walk 1 Direction	To SW		X Walk 2 Direction	N/A	
N/A	X Walk 1 Width (in)	N/A	N/A	X Walk 2 Width (in)	N/A	
	X Walk 1 Slope (%)	3.8		X Walk 2 Slope (%)	N/A

X Walk 1 X Slope (%)	4.0		X Walk 2 X Slope (%)	N/A	
N/A	Ramp inside XWalk1?	N/A	N/A	Ramp inside XWalk2?	N/A	
	Road Slope (%)	N/A	N/A	Clear Space?	Yes	
	Road X Slope (%)	N/A	N/A	Clear Space to XWalk (in)	N/A	
Yes	Any Obstructions?	No	Yes	Storm Grate/Utility Hazard?	No	
	Obstruction Type			Storm Grate/Utility Type		
		N/A			N/A	
			Yes	Surface Condition? (G/P)	Good

Possible Solutions: Remove & Replace Entire Ramp. Remove & Replace Gutter. Surveyor Notes: N/A PROW/ADA: Not Found, R304.5.3, R304.2.1, R304.2.2-Perp, R304.3.2-Para
