Access Compliance Report Public Rights-of-Way (Curb Ramps)

Intersection ID: 8201 Main Street: INGLE_ST Cross Street: KENTUCKY_AV Location: N

ADA ID: 2EF5D72B60EA Ramp Type: Para Initial Pass/Fail: Fail Overall Compliance: No Severity Score: 12.5

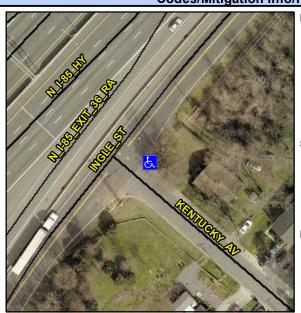
Field Measuremer Compliance Description		Data	Compliance Description		Data
N/A	Ramp Length LT (in)	48.0	N/A	Ramp Length RT (in)	50.0
Yes	Ramp Width LT (in)	72.5	Yes	Ramp Width RT (in)	70.5
No	Ramp Slope LT (%)	10.3	Yes	Ramp Slope RT (%)	6.6
Yes	Ramp XSlope LT (%)	1.1	Yes	Ramp XSlope RT (%)	1.9
N/A	Landing Length (in)	N/A	N/A	DWS Provided?	N/A
N/A	Landing Width (in)	N/A	N/A	DWS Contrast?	N/A
N/A	Landing Slope (%)	N/A	N/A	DWS Length (in)	N/A
N/A	Landing X Slope (%)	N/A	N/A	DWS Full Width?	N/A
N/A	Landing Curb? (Y/N)	N/A	N/A	DWS Offset (in)	N/A
N/A	Shared Landing?	N/A			
N/A	Gutter Ponding?	N/A	N/A	Gutter Slope (%)	N/A
N/A	Gutter Lip Ht (in)	N/A	N/A	Gutter X Slope (%)	N/A
N/A	Painted X Walk1?	No	N/A	Painted X Walk2?	N/A
	X Walk 1 Direction	To SW		X Walk 2 Direction	N/A
N/A	X Walk 1 Width (in)	N/A	N/A	X Walk 2 Width (in)	N/A
	X Walk 1 Slope (%)	6.8		X Walk 2 Slope (%)	N/A
	X Walk 1 X Slope (%)	3.6		X Walk 2 X Slope (%)	N/A

N/A	Ramp inside XWalk1?	N/A	N/A	Ramp inside XWalk2?	N/A
	Road Slope (%)	N/A	N/A	Clear Space?	N/A
	Road X Slope (%)	N/A	N/A	Clear Space to XWalk (in)	N/A
N/A	Any Obstructions?	N/A	N/A	Storm Grate/Utility Hazard?	N/A
	Obstruction Type			Storm Grate/Utility Type	
		N/A			N/A
			Yes	Surface Condition? (G/P)	Good
			N/A	Curb Slope (%)	33.0

Possible Solutions:

Remove & Replace Entire Ramp.

R304.3.2
