# Access Compliance Report

## Public Rights-of-Way

### (Curb Ramps)

Intersection ID: 46147	Main Street: ROCKY_FORD_CLUB_RD	Cross Street: ARBOR_CREEK_DR	Location: SW
ADA ID: 2EF96067F8D0	Ramp Type: PerpDiag	Initial Pass/Fail: Fail	Overall Compliance: No
Severity Score: 13.75			
Codes/Mitigation Info/Possible Solution		Field Measurements/Component Compliance

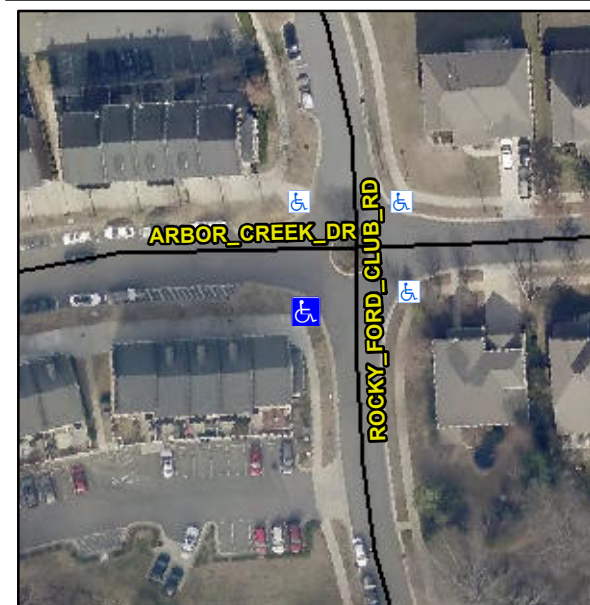
Compliance	Description	Data	Compliance	Description	Data
N/A	Ramp Length (in)	108.0	No	Ramp Slope (%)	8.6
Yes	Ramp Width (in)	48.0	No	Ramp XSlope (%)	4.9
N/A	Flare Type LT	N/A	N/A	Flare Type RT	N/A
N/A	Flare Slope LT (%)	N/A	N/A	Flare Slope RT (%)	N/A
N/A	Flare Traversable LT?	N/A	N/A	Flare Traversable RT?	N/A
N/A	Landing Length (in)	N/A	N/A	DWS Provided?	N/A
N/A	Landing Width (in)	N/A	N/A	DWS Contrast?	N/A
N/A	Landing Slope (%)	N/A	N/A	DWS Length (in)	N/A
N/A	Landing X Slope (%)	N/A	N/A	DWS Full Width?	N/A
N/A	Landing Curb? (Y/N)	N/A	N/A	DWS Offset (in)	N/A
N/A	Shared Landing?	N/A			
N/A	Gutter Ponding?	N/A	N/A	Gutter Slope (%)	N/A
N/A	Gutter Lip Ht (in)	N/A	N/A	Gutter X Slope (%)	N/A
N/A	Painted X Walk1?	No	N/A	Painted X Walk2?	No
	X Walk 1 Direction	To E		X Walk 2 Direction	To N
N/A	X Walk 1 Width (in)	N/A	N/A	X Walk 2 Width (in)	N/A
	X Walk 1 Slope (%)	2.5		X Walk 2 Slope (%)	0.9
	X Walk 1 X Slope (%)	3.4		X Walk 2 X Slope (%)	4.0

N/A	Ramp inside XWalk1?	N/A	N/A	Ramp inside XWalk2?	N/A
	Road Slope (%)	5.9	N/A	Clear Space?	N/A
	Road X Slope (%)	3.0	N/A	Clear Space to XWalk (in)	N/A
N/A	Any Obstructions?	N/A	N/A	Storm Grate/Utility Hazard?	N/A
	Obstruction Type			Storm Grate/Utility Type	
		N/A			N/A
			Yes	Surface Condition? (G/P)	Good

**Remove & Replace Curb Ramp With Two New Directional Ramps or Equivalent.**

**R304.2.2, R304.5.3**

Total Cost: \$ 3200.00
