Access Compliance Report

Public Rights-of-Way

(Curb Ramps)

Intersection ID: 13507	Main Street: OLD_STEELE_CREEK_RD	Cross Street: WINGATE_AV	Location: SW
ADA ID: 2EF9F5938F54	Ramp Type: ParaDiag	Initial Pass/Fail: Fail	Overall Compliance: No
Codes/Mitigation Info/Possible Solution		Field Measurements/Component Compliance	
Severity Score: 22.5

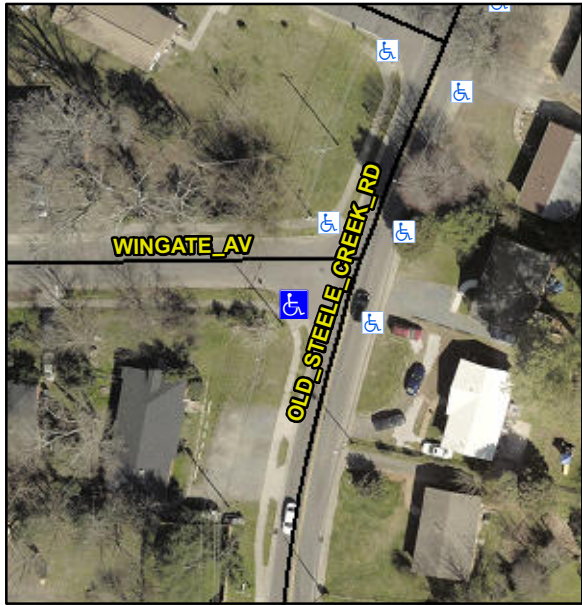
Compliance	Description	Data	Compliance	Description	Data
N/A	Ramp Length LT (in)	63.0	N/A	Ramp Length RT (in)	54.0
No	Ramp Width LT (in)	47.0	Yes	Ramp Width RT (in)	48.0
No	Ramp Slope LT (%)	9.3	Yes	Ramp Slope RT (%)	6.2
No	Ramp XSlope LT (%)	2.2	No	Ramp XSlope RT (%)	2.4
N/A	Landing Length (in)	N/A	N/A	DWS Provided?	N/A
N/A	Landing Width (in)	N/A	N/A	DWS Contrast?	N/A
N/A	Landing Slope (%)	N/A	N/A	DWS Length (in)	N/A
N/A	Landing X Slope (%)	N/A	N/A	DWS Full Width?	N/A
N/A	Landing Curb? (Y/N)	N/A	N/A	DWS Offset (in)	N/A
N/A	Shared Landing?	N/A			
N/A	Gutter Ponding?	N/A	N/A	Gutter Slope (%)	N/A
N/A	Gutter Lip Ht (in)	N/A	N/A	Gutter X Slope (%)	N/A
N/A	Painted X Walk1?	No	N/A	Painted X Walk2?	No
	X Walk 1 Direction	To E		X Walk 2 Direction	To N
N/A	X Walk 1 Width (in)	N/A	N/A	X Walk 2 Width (in)	N/A
	X Walk 1 Slope (%)	1.2		X Walk 2 Slope (%)	1.4
	X Walk 1 X Slope (%)	0.5		X Walk 2 X Slope (%)	0.3
N/A	Ramp inside XWalk1?	N/A	N/A	Ramp inside XWalk2?	N/A

Road Slope (%)	0.7	N/A	Clear Space?	N/A
	Road X Slope (%)	1.4	N/A	Clear Space to XWalk (in)	N/A
N/A	Any Obstructions?	N/A	N/A	Storm Grate/Utility Hazard?	N/A
	Obstruction Type			Storm Grate/Utility Type	
		N/A			N/A
			Yes	Surface Condition? (G/P)	Good
			N/A	Curb Slope (%)	13.3

Remove & Replace Curb Ramp With Two New Directional Ramps or Equivalent.

R304.5.1, R304.3.2, R304.5.3

3200.00
