# Access Compliance Report

## Public Rights-of-Way

| Intersection ID: 32245 | Main Street: BALMORAL PARK DR | Cross Street: OXFORD COMMONS DR | Location: SW |
| ADA ID: 2EFC24A749B5 | Ramp Type: PerpDiag | Initial Pass/Fail: Fail | Overall Compliance: No |

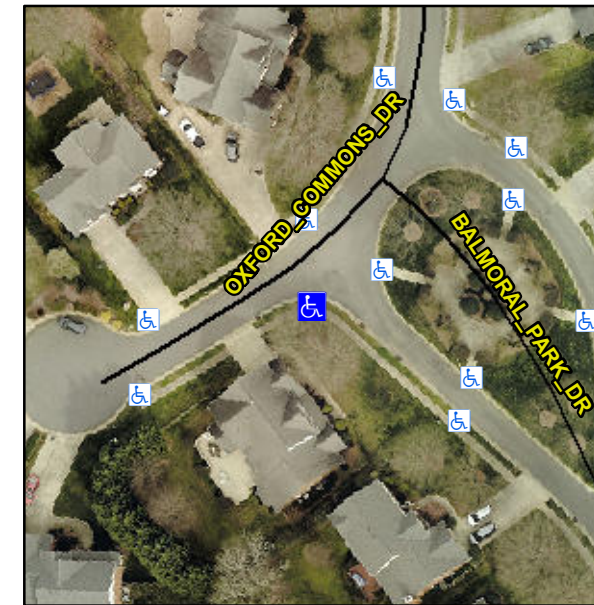
**Not Found, R304.5.1, R304.2.2, R304.5.3**

| Compliance | Description | Data | Compliance | Description | Data |
|---|---|---|---|---|---|
| N/A | Ramp Length (in) | 48.0 | No | Ramp Slope (%) | 10.1 |
| No | Ramp Width (in) | 43.0 | No | Ramp XSlope (%) | 5.0 |

**Remove & Replace Curb Ramp With Two New Directional Ramps or Equivalent.**
