Access Compliance Report

Public Rights-of-Way

(Curb Ramps)

Intersection ID: 48787	Main Street: LOST_PINE_RD	Cross Street: LOST_OAK_RD	Location: S
ADA ID: 2F01BDA2A530	Ramp Type: PerpDiag	Initial Pass/Fail: Fail	Overall Compliance: No
			Severity Score: 33.75

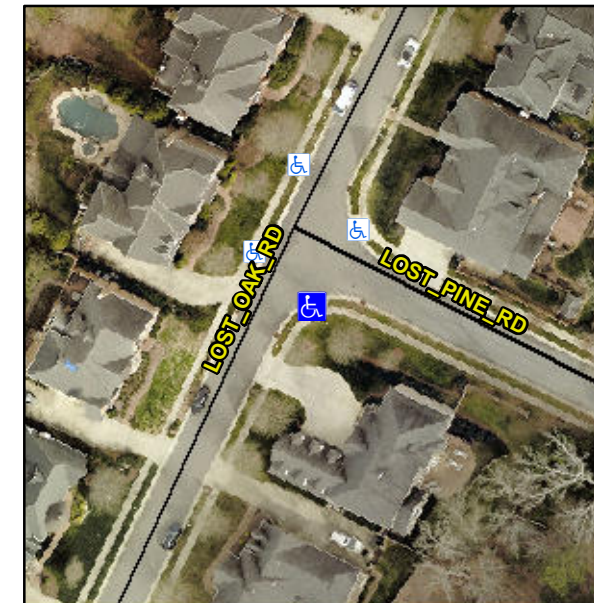
Compliance	Description	Data	Compliance	Description	Data
N/A	Ramp Length (in)	95.0	Yes	Ramp Slope (%)	6.3
No	Ramp Width (in)	40.0	No	Ramp XSlope (%)	8.4
N/A	Flare Type LT	N/A	N/A	Flare Type RT	N/A
N/A	Flare Slope LT (%)	N/A	N/A	Flare Slope RT (%)	N/A
N/A	Flare Traversable LT?	N/A	N/A	Flare Traversable RT?	N/A
N/A	Landing Length (in)	N/A	N/A	DWS Provided?	N/A
N/A	Landing Width (in)	N/A	N/A	DWS Contrast?	N/A
N/A	Landing Slope (%)	N/A	N/A	DWS Length (in)	N/A
N/A	Landing X Slope (%)	N/A	N/A	DWS Full Width?	N/A
N/A	Landing Curb? (Y/N)	N/A	N/A	DWS Offset (in)	N/A
N/A	Shared Landing?	N/A			
N/A	Gutter Ponding?	N/A	N/A	Gutter Slope (%)	N/A
N/A	Gutter Lip Ht (in)	N/A	N/A	Gutter X Slope (%)	N/A
N/A	Painted X Walk1?	No	N/A	Painted X Walk2?	No
	X Walk 1 Direction	To NE		X Walk 2 Direction	To NW
N/A	X Walk 1 Width (in)	N/A	N/A	X Walk 2 Width (in)	N/A
	X Walk 1 Slope (%)	2.6		X Walk 2 Slope (%)	2.5
	X Walk 1 X Slope (%)	4.1		X Walk 2 X Slope (%)	3.4

N/A	Ramp inside XWalk1?	N/A	N/A	Ramp inside XWalk2?	N/A
	Road Slope (%)	5.0	N/A	Clear Space?	N/A
	Road X Slope (%)	2.5	N/A	Clear Space to XWalk (in)	N/A
N/A	Any Obstructions?	N/A	N/A	Storm Grate/Utility Hazard?	N/A
	Obstruction Type			Storm Grate/Utility Type	
		N/A			N/A
			Yes	Surface Condition? (G/P)	Good

Remove & Replace Curb Ramp With Two New Directional Ramps or Equivalent.

R304.5.1, R304.5.3
