# Access Compliance Report

## Public Rights-of-Way

### (Curb Ramps)

| Intersection ID: 45515 | Main Street: COTTON_PRESS_RD | Cross Street: HEDGEROW_PARK_RD | Location: NE |

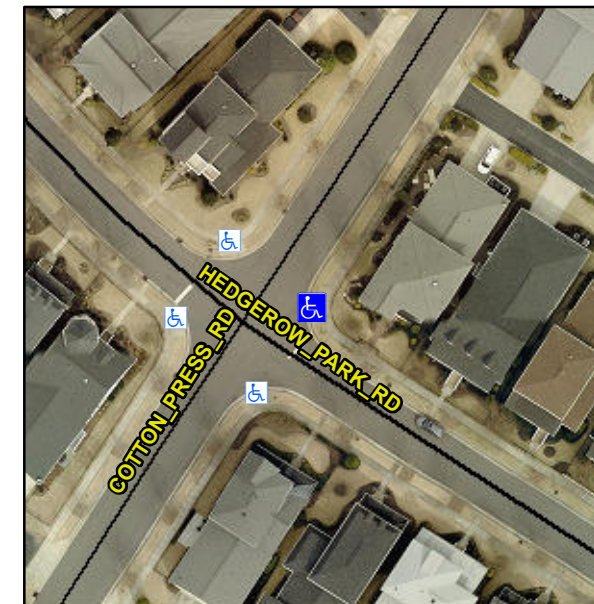
| ADA ID: 2F038664F5F1 | Ramp Type: Combination1Diag | Initial Pass/Fail: Fail | Overall Compliance: No |

**RT RP < 5%**

| Compliance | Description | Data | Compliance | Description | Data |
|---|---|---|---|---|---|
| Yes | Ramp Slope LT (%) | 5.6 | Yes | Ramp Slope RT (%) | 2.5 |
| No | Ramp XSlope LT (%) | 2.8 | Yes | Ramp XSlope RT (%) | 1.8 |
| N/A | Ramp Length (in) | 72.0 | No | Ramp Slope (%) | 10.5 |
| No | Ramp Width (in) | 33.0 | No | Ramp XSlope (%) | 4.2 |

**Remove & Replace Curb Ramp With Two New Directional Ramps or Equivalent.**

**R304.5.1, R304.2.2, R304.5.3**

Total Cost: \$ 3200.00
