Access Compliance Report

Public Rights-of-Way

(Curb Ramps)

Intersection ID: 51323	Main Street: GLENMORE_GARDEN_DR	Cross Street: MCKEE_RD	Location: SW
ADA ID: 2F073D9D1DD5	Ramp Type: Perp	Initial Pass/Fail: Fail	Overall Compliance: No
			Severity Score: 21.25

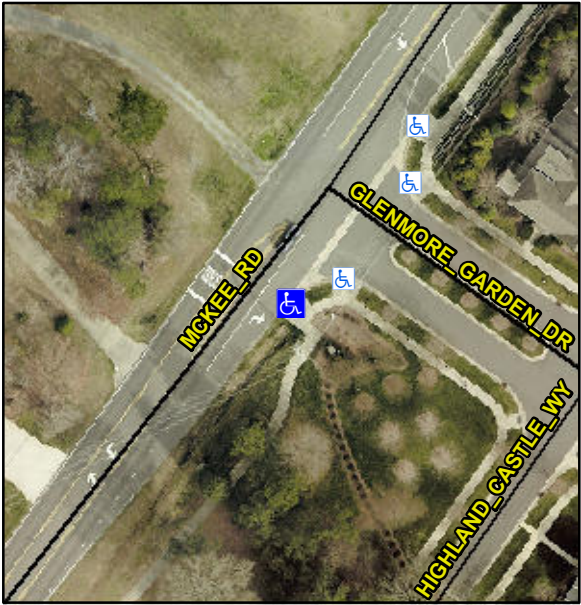
Possible Solutions:		Compliance	Description	Data
	Remove & Replace Entire Ramp.		N/A	Ramp Length (in)	102.0
			No	Ramp Width (in)	46.0
			N/A	Flare Type LT	N/A
			N/A	Flare Slope LT (%)	N/A
			N/A	Flare Traversable LT?	N/A
			N/A	Landing Length (in)	N/A
			N/A	Landing Width (in)	N/A
			N/A	Landing Slope (%)	N/A
			N/A	Landing X Slope (%)	N/A
<p>Surveyor Notes:</p> <p>N/A</p> <p>PROW/ADA:</p> <p>R304.5.1, R304.2.2</p>			N/A	Flare Type RT	N/A
			N/A	Flare Slope RT (%)	N/A
			N/A	Flare Traversable RT?	N/A
			N/A	DWS Provided?	N/A
			N/A	DWS Contrast?	N/A
			N/A	DWS Length (in)	N/A
			N/A	DWS Full Width?	N/A
			N/A	DWS Offset (in)	N/A
			N/A	Shared Landing?	N/A
			N/A	Gutter Ponding?	N/A
			N/A	Gutter Lip Ht (in)	N/A
			N/A	Painted X Walk1?	No
				X Walk 1 Direction	To NW
			N/A	X Walk 1 Width (in)	N/A
				X Walk 1 Slope (%)	1.2
				X Walk 1 X Slope (%)	0.9

N/A	Ramp inside XWalk1?	N/A
				Road Slope (%)	N/A
				Road X Slope (%)	N/A
			N/A	Any Obstructions?	N/A
				Obstruction Type	
			N/A		N/A
			Yes	Surface Condition? (G/P)	Good

Total Cost: \$ 1850.00
