Access Compliance Report

Public Rights-of-Way

(Curb Ramps)

Intersection ID: 47575	Main Street: GLENBURN_LN	Cross Street: GAILES_DR	Location: NW
ADA ID: 2F089BA149DD	Ramp Type: PerpDiag	Initial Pass/Fail: Fail	Overall Compliance: No
Severity Score: 25			
Codes/Mitigation Info/Possible Solution		Field Measurements/Component Compliance

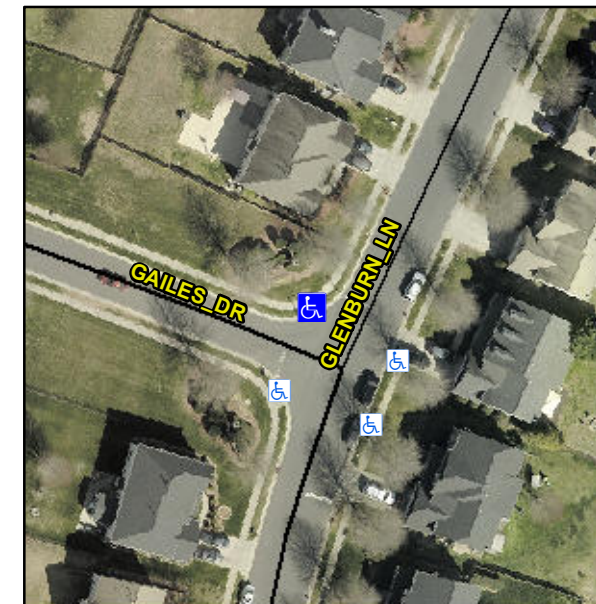
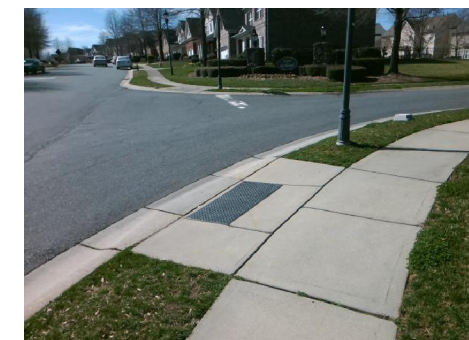
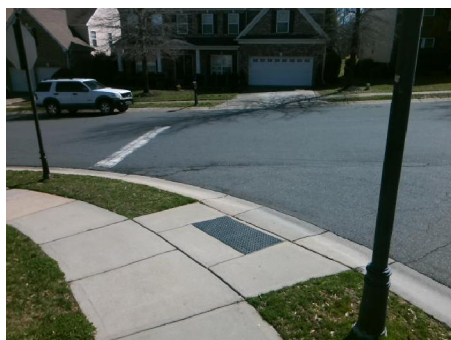
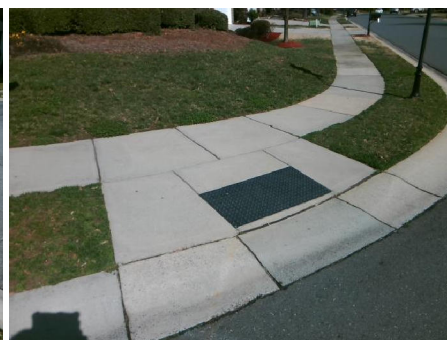
Compliance	Description	Data	Compliance	Description	Data
N/A	Ramp Length (in)	49.0	Yes	Ramp Slope (%)	6.3
Yes	Ramp Width (in)	48.0	No	Ramp XSlope (%)	9.1
N/A	Flare Type LT	N/A	N/A	Flare Type RT	N/A
N/A	Flare Slope LT (%)	N/A	N/A	Flare Slope RT (%)	N/A
N/A	Flare Traversable LT?	N/A	N/A	Flare Traversable RT?	N/A
N/A	Landing Length (in)	N/A	N/A	DWS Provided?	N/A
N/A	Landing Width (in)	N/A	N/A	DWS Contrast?	N/A
N/A	Landing Slope (%)	N/A	N/A	DWS Length (in)	N/A
N/A	Landing X Slope (%)	N/A	N/A	DWS Full Width?	N/A
N/A	Landing Curb? (Y/N)	N/A	N/A	DWS Offset (in)	N/A
N/A	Shared Landing?	N/A			
N/A	Gutter Ponding?	N/A	N/A	Gutter Slope (%)	N/A
N/A	Gutter Lip Ht (in)	N/A	N/A	Gutter X Slope (%)	N/A
N/A	Painted X Walk1?	No	N/A	Painted X Walk2?	No
	X Walk 1 Direction	To SW		X Walk 2 Direction	To SE
N/A	X Walk 1 Width (in)	N/A	N/A	X Walk 2 Width (in)	N/A
	X Walk 1 Slope (%)	6.5		X Walk 2 Slope (%)	3.5
	X Walk 1 X Slope (%)	3.7		X Walk 2 X Slope (%)	6.2

N/A	Ramp inside XWalk1?	N/A	N/A	Ramp inside XWalk2?	N/A
	Road Slope (%)	9.1	N/A	Clear Space?	N/A
	Road X Slope (%)	1.5	N/A	Clear Space to XWalk (in)	N/A
N/A	Any Obstructions?	N/A	N/A	Storm Grate/Utility Hazard?	N/A
	Obstruction Type			Storm Grate/Utility Type	
		N/A			N/A
		Yes		Surface Condition? (G/P)	Good

Remove & Replace Curb Ramp With Two New Directional Ramps or Equivalent.

R304.5.3
