Access Compliance Report

Public Rights-of-Way

(Curb Ramps)

Intersection ID: N/A	Main Street: TRAILMOOR_RD	Cross Street: BRECKFIELD_CT	Location: NE
ADA ID: 2F08C39B5875	Ramp Type: PerpDiag	Initial Pass/Fail: Fail	Overall Compliance: No
Codes/Mitigation Info/Possible Solution		Field Measurements/Component Compliance	
Severity Score: 21.25

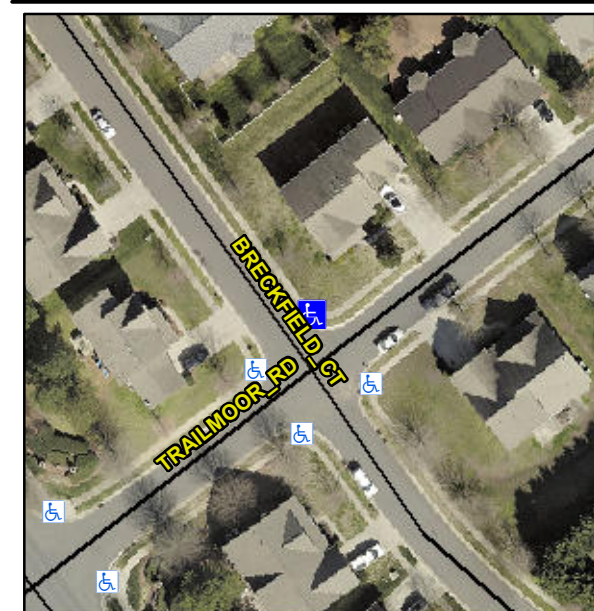
Compliance	Description	Data	Compliance	Description	Data
N/A	Ramp Length (in)	48.0	Yes	Ramp Slope (%)	7.9
No	Ramp Width (in)	46.0	No	Ramp XSlope (%)	5.2
N/A	Flare Type LT	N/A	N/A	Flare Type RT	N/A
N/A	Flare Slope LT (%)	N/A	N/A	Flare Slope RT (%)	N/A
N/A	Flare Traversable LT?	N/A	N/A	Flare Traversable RT?	N/A
N/A	Landing Length (in)	N/A	N/A	DWS Provided?	N/A
N/A	Landing Width (in)	N/A	N/A	DWS Contrast?	N/A
N/A	Landing Slope (%)	N/A	N/A	DWS Length (in)	N/A
N/A	Landing X Slope (%)	N/A	N/A	DWS Full Width?	N/A
N/A	Landing Curb? (Y/N)	N/A	N/A	DWS Offset (in)	N/A
N/A	Shared Landing?	N/A			
N/A	Gutter Ponding?	N/A	N/A	Gutter Slope (%)	N/A
N/A	Gutter Lip Ht (in)	N/A	N/A	Gutter X Slope (%)	N/A
N/A	Painted X Walk1?	No	N/A	Painted X Walk2?	No
	X Walk 1 Direction	To SW		X Walk 2 Direction	To SE
N/A	X Walk 1 Width (in)	N/A	N/A	X Walk 2 Width (in)	N/A
	X Walk 1 Slope (%)	0.0		X Walk 2 Slope (%)	3.3
	X Walk 1 X Slope (%)	1.7		X Walk 2 X Slope (%)	1.2

N/A	Ramp inside XWalk1?	N/A	N/A	Ramp inside XWalk2?	N/A
	Road Slope (%)	2.2	N/A	Clear Space?	N/A
	Road X Slope (%)	0.1	N/A	Clear Space to XWalk (in)	N/A
N/A	Any Obstructions?	N/A	N/A	Storm Grate/Utility Hazard?	N/A
	Obstruction Type			Storm Grate/Utility Type	
		N/A			N/A
			Yes	Surface Condition? (G/P)	Good

Possible Solutions:

Remove & Replace Curb Ramp With Two New Directional Ramps or Equivalent.
