Intersection ID: 10014838	Main Street: THE_PLAZA	Cross Street: N/A	Location:	NE
ADA ID: 2F111ACD62E6	Ramp Type: PerpDiag	Initial Pass/Fail: Fail	Overall Compliance: No	Severity Score: 13.75

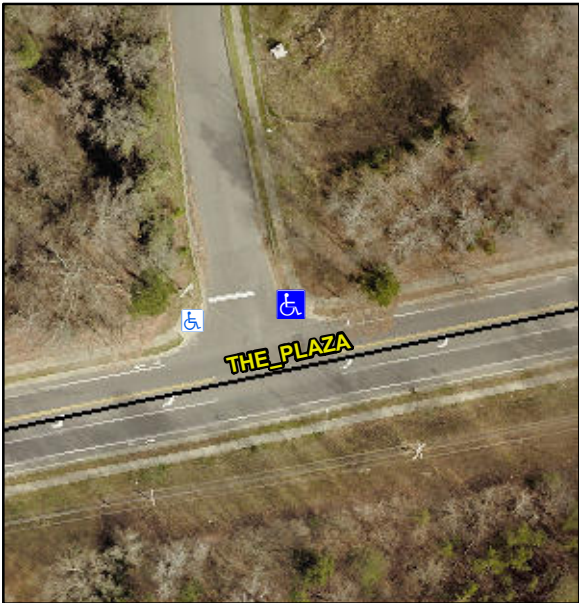
Possible Solutions:		Compliance	Description	Data	Compliance	Description	Data
	Remove & Replace Curb Ramp With Two New Directional Ramps or Equivalent.		N/A	Ramp Length (in)	47.0	No	Ramp Slope (%)	8.9
			Yes	Ramp Width (in)	48.0	No	Ramp XSlope (%)	3.3
			N/A	Flare Type LT	N/A	N/A	Flare Type RT	N/A
			N/A	Flare Slope LT (%)	N/A	N/A	Flare Slope RT (%)	N/A
			N/A	Flare Traversable LT?	N/A	N/A	Flare Traversable RT?	N/A
			N/A	Landing Length (in)	N/A	N/A	DWS Provided?	N/A
			N/A	Landing Width (in)	N/A	N/A	DWS Contrast?	N/A
			N/A	Landing Slope (%)	N/A	N/A	DWS Length (in)	N/A
			N/A	Landing X Slope (%)	N/A	N/A	DWS Full Width?	N/A
Surveyor Notes:		N/A	N/A	Landing Curb? (Y/N)	N/A	N/A	DWS Offset (in)	N/A
			N/A	Shared Landing?	N/A			
PROW/ADA:			N/A	Gutter Ponding?	N/A	N/A	Gutter Slope (%)	N/A
Not Found, R304.2.2, R304.5.3		N/A	N/A	Gutter Lip Ht (in)	N/A	N/A	Gutter X Slope (%)	N/A

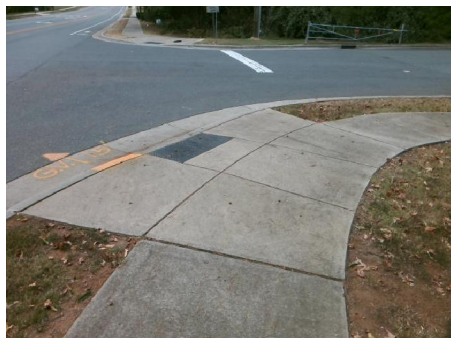
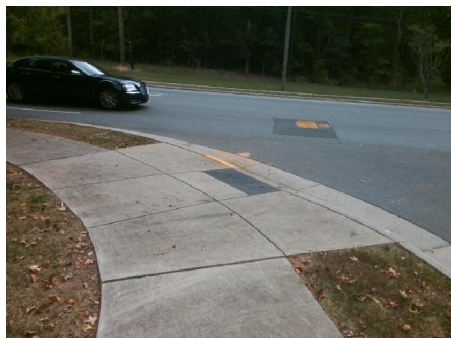
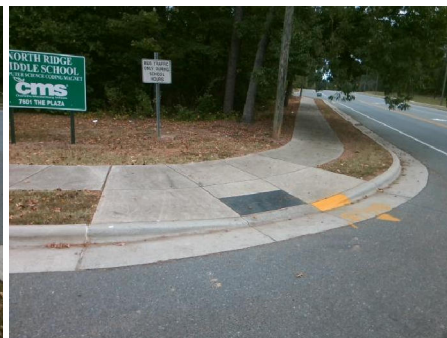
N/A	N/A	Painted X Walk1?	No	N/A	Painted X Walk2?	No
				X Walk 1 Direction	To W		X Walk 2 Direction	To S
		N/A	N/A	X Walk 1 Width (in)	N/A	N/A	X Walk 2 Width (in)	N/A
				X Walk 1 Slope (%)	1.2		X Walk 2 Slope (%)	1.2
				X Walk 1 X Slope (%)	2.0		X Walk 2 X Slope (%)	2.1
		N/A	N/A	Ramp inside XWalk1?	N/A	N/A	Ramp inside XWalk2?	N/A
				Road Slope (%)	2.6	N/A	Clear Space?	N/A
				Road X Slope (%)	0.4	N/A	Clear Space to XWalk (in)	N/A
		N/A	N/A	Any Obstructions?	N/A	N/A	Storm Grate/Utility Hazard?	N/A
				Obstruction Type			Storm Grate/Utility Type	
					N/A			N/A
						Yes	Surface Condition? (G/P)	Good
Total Cost:		\$	3200.00					
Street 1 Name		ENTRANCE						
Stop Condition-Street 2		StopSign						
Street 2 Name		THE PLAZA						
Stop Condition-Street 1		None
