## Access Compliance Report Public Rights-of-Way (Curb Ramps)

Intersection ID: 14381Main Street: CARLTON\_AVCross Street: ROMANY\_RDLocation:NEADA ID: 2F14877E76F8Ramp Type: PerpInitial Pass/Fail: FailOverall Compliance: NoSeverity Score: 12.5

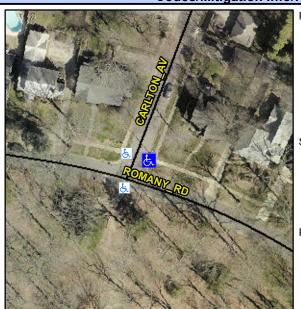
Not Found, R304.5.3

Field Measurements/Component Compliance						
Compliance Description			Data	Compliance Description		Data
N	I/A	Ramp Length (in)	48.0	Yes	Ramp Slope (%)	7.5
Υ	'es	Ramp Width (in)	48.0	No	Ramp XSlope (%)	6.4
N	l/A	Flare Type LT	N/A	N/A	Flare Type RT	N/A
N	I/A	Flare Slope LT (%)	N/A	N/A	Flare Slope RT (%)	N/A
N	I/A	Flare Traversable LT?	N/A	N/A	Flare Traversable RT?	N/A
N	I/A	Landing Length (in)	N/A	N/A	DWS Provided?	N/A
N	I/A	Landing Width (in)	N/A	N/A	DWS Contrast?	N/A
N	I/A	Landing Slope (%)	N/A	N/A	DWS Length (in)	N/A
N	I/A	Landing X Slope (%)	N/A	N/A	DWS Full Width?	N/A
N	I/A	Landing Curb? (Y/N)	N/A	N/A	DWS Offset (in)	N/A
N	I/A	Shared Landing?	N/A			
N	I/A	Gutter Ponding?	N/A	N/A	Gutter Slope (%)	N/A
N	l/A	Gutter Lip Ht (in)	2.0	N/A	Gutter X Slope (%)	N/A
N	I/A	Painted X Walk1?	No	N/A	Painted X Walk2?	N/A
		X Walk 1 Direction	To W		X Walk 2 Direction	N/A
N	I/A	X Walk 1 Width (in)	N/A	N/A	X Walk 2 Width (in)	N/A

X Walk 1 Slope (%)	6.2		X Walk 2 Slope (%)	N/A
		X Walk 1 X Slope (%)	0.3		X Walk 2 X Slope (%)	N/A
N	I/A	Ramp inside XWalk1?	N/A	N/A	Ramp inside XWalk2?	N/A
		Road Slope (%)	N/A	N/A	Clear Space?	N/A
		Road X Slope (%)	N/A	N/A	Clear Space to XWalk (in)	N/A
N	I/A	Any Obstructions?	N/A	N/A	Storm Grate/Utility Hazard?	N/A
		Obstruction Type			Storm Grate/Utility Type	
			N/A			N/A
				Yes	Surface Condition? (G/P)	Good

Remove & Replace Entire Ramp.

Total Cost: \$ 1850.00
