Access Compliance Report

Public Rights-of-Way

(Curb Ramps)

Intersection ID: N/A	Main Street: S_CALDWELL_ST	Cross Street: E_STONEWALL_ST	Location: NW
ADA ID: 2F1C561F5BD1	Ramp Type: Perp	Initial Pass/Fail: Pass	Overall Compliance: No
Severity Score: 0			
Codes/Mitigation Info/Possible Solution		Field Measurements/Component Compliance

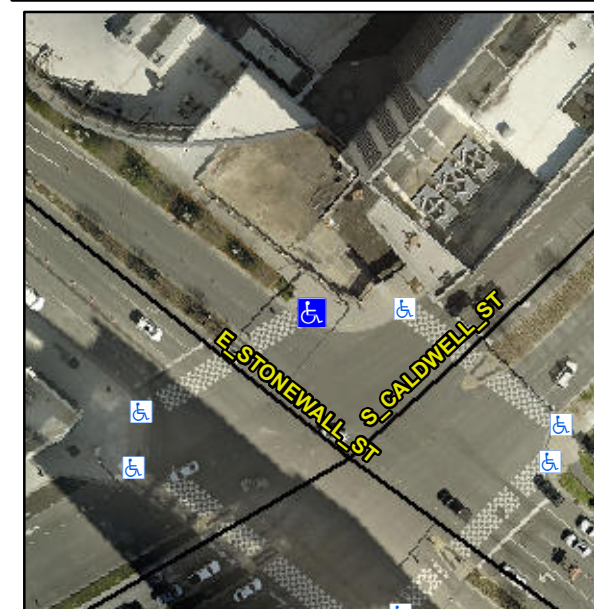
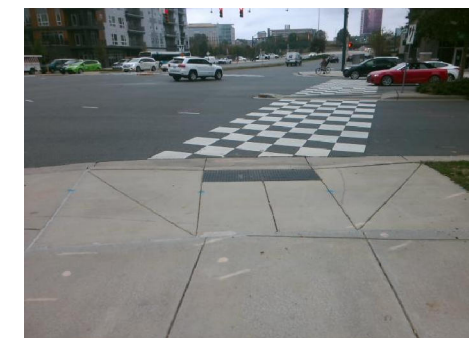
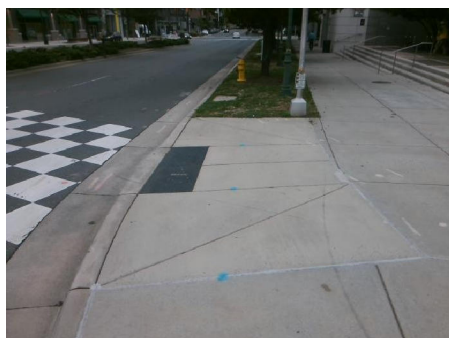
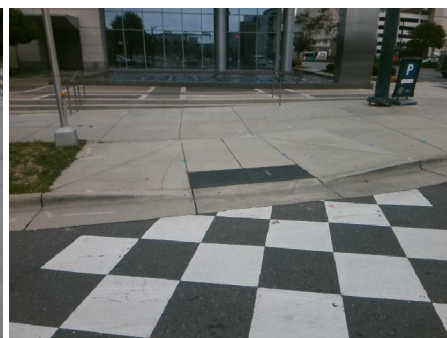
Not Found, R304.5.3

Compliance	Description	Data	Compliance	Description	Data
N/A	Ramp Length (in)	96.0	Yes	Ramp Slope (%)	6.5
Yes	Ramp Width (in)	62.0	Yes	Ramp XSlope (%)	2.0
N/A	Flare Type LT	Sloped	N/A	Flare Type RT	N/A
N/A	Flare Slope LT (%)	4.6	Yes	Flare Slope RT (%)	9.6
N/A	Flare Traversable LT?	No	N/A	Flare Traversable RT?	Yes
Yes	Landing Length (in)	48.0	Yes	DWS Provided?	Yes
Yes	Landing Width (in)	48.0	Yes	DWS Contrast?	Yes
Yes	Landing Slope (%)	1.6	Yes	DWS Length (in)	24.5
Yes	Landing X Slope (%)	1.3	Yes	DWS Full Width?	Yes
N/A	Landing Curb? (Y/N)	No	Yes	DWS Offset (in)	0.0
N/A	Shared Landing?	No			
Yes	Gutter Ponding?	No	Yes	Gutter Slope (%)	3.6
Yes	Gutter Lip Ht (in)	0.0	No	Gutter X Slope (%)	4.2
N/A	Painted X Walk1?	Yes	N/A	Painted X Walk2?	N/A
	X Walk 1 Direction	To SW		X Walk 2 Direction	N/A
N/A	X Walk 1 Width (in)	144.0	N/A	X Walk 2 Width (in)	N/A
	X Walk 1 Slope (%)	0.3		X Walk 2 Slope (%)	N/A
	X Walk 1 X Slope (%)	3.2		X Walk 2 X Slope (%)	N/A

Yes	Ramp inside XWalk1?	Yes	N/A	Ramp inside XWalk2?	N/A
	Road Slope (%)	N/A	N/A	Clear Space?	Yes
	Road X Slope (%)	N/A	N/A	Clear Space to XWalk (in)	N/A
Yes	Any Obstructions?	No	Yes	Storm Grate/Utility Hazard?	No
	Obstruction Type			Storm Grate/Utility Type	
		N/A			N/A
			Yes	Surface Condition? (G/P)	Good

**Remove & Replace Entire Ramp.
Remove & Replace Gutter.**

Total Cost: \$ 2600.00
