Access Compliance Report

Public Rights-of-Way

(Curb Ramps)

Intersection ID: 23832	Main Street: KIBWORTH_LN	Cross Street: WAGONFORD_LN	Location: S
ADA ID: 2F1E896022CF	Ramp Type: Perp	Initial Pass/Fail: Fail	Overall Compliance: No
Severity Score: 12.5			
Codes/Mitigation Info/Possible Solution		Field Measurements/Component Compliance

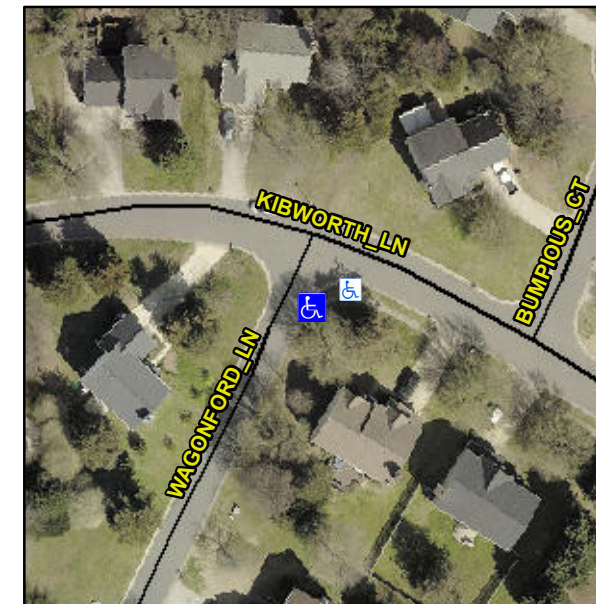
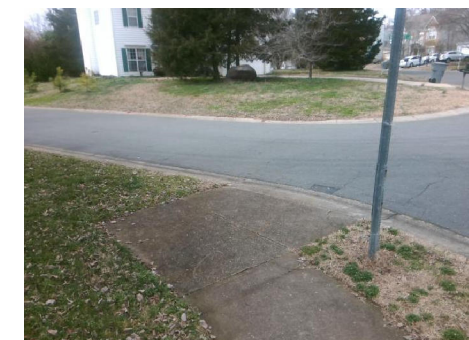
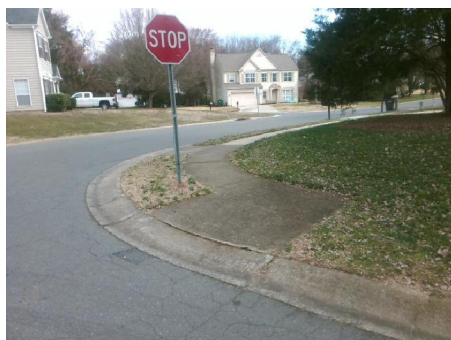
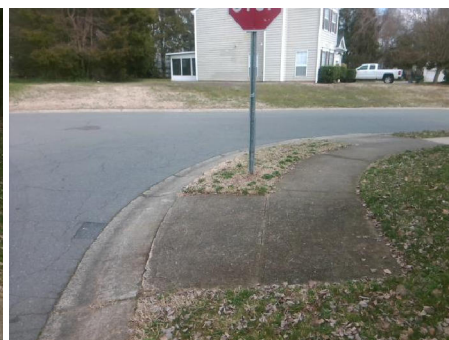
Compliance	Description	Data	Compliance	Description	Data
N/A	Ramp Length (in)	45.0	No	Ramp Slope (%)	8.9
Yes	Ramp Width (in)	91.0	Yes	Ramp XSlope (%)	0.8
N/A	Flare Type LT	N/A	N/A	Flare Type RT	N/A
N/A	Flare Slope LT (%)	N/A	N/A	Flare Slope RT (%)	N/A
N/A	Flare Traversable LT?	N/A	N/A	Flare Traversable RT?	N/A
N/A	Landing Length (in)	N/A	N/A	DWS Provided?	N/A
N/A	Landing Width (in)	N/A	N/A	DWS Contrast?	N/A
N/A	Landing Slope (%)	N/A	N/A	DWS Length (in)	N/A
N/A	Landing X Slope (%)	N/A	N/A	DWS Full Width?	N/A
N/A	Landing Curb? (Y/N)	N/A	N/A	DWS Offset (in)	N/A
N/A	Shared Landing?	N/A			
N/A	Gutter Ponding?	N/A	N/A	Gutter Slope (%)	N/A
N/A	Gutter Lip Ht (in)	N/A	N/A	Gutter X Slope (%)	N/A
N/A	Painted X Walk1?	No	N/A	Painted X Walk2?	N/A
	X Walk 1 Direction	To NW		X Walk 2 Direction	N/A
N/A	X Walk 1 Width (in)	N/A	N/A	X Walk 2 Width (in)	N/A
	X Walk 1 Slope (%)	3.8		X Walk 2 Slope (%)	N/A
	X Walk 1 X Slope (%)	2.3		X Walk 2 X Slope (%)	N/A

N/A	Ramp inside XWalk1?	N/A	N/A	Ramp inside XWalk2?	N/A
	Road Slope (%)	N/A	N/A	Clear Space?	N/A
	Road X Slope (%)	N/A	N/A	Clear Space to XWalk (in)	N/A
N/A	Any Obstructions?	N/A	N/A	Storm Grate/Utility Hazard?	N/A
	Obstruction Type			Storm Grate/Utility Type	
		N/A			N/A
			Yes	Surface Condition? (G/P)	Good

Possible Solutions:

Remove & Replace Entire Ramp.

R304.2.2
